SUBJECT ACCIDENT TO VP-FAY (Islander)
..... @ V HILL COVE.

I have the honour to inform you of an aircraft incident involving ISLANDER VP-FAY at HILL COVE on February 12th 1980

Following the notification, in accordance with Regulation 4 of the Civil Aviation (Investigation of Accidents) Regulations, 1959, of an accident which occurred to the Falkland Islands Government Air Service aircraft VP-FAY on 12th February 1980 at Hill Cove, West Falkland, I hereby appoint you, under Regulation 7 of the said Regulations, as Inspector for the purpose of carrying out an investigation into the causes and circumstances of this accident.

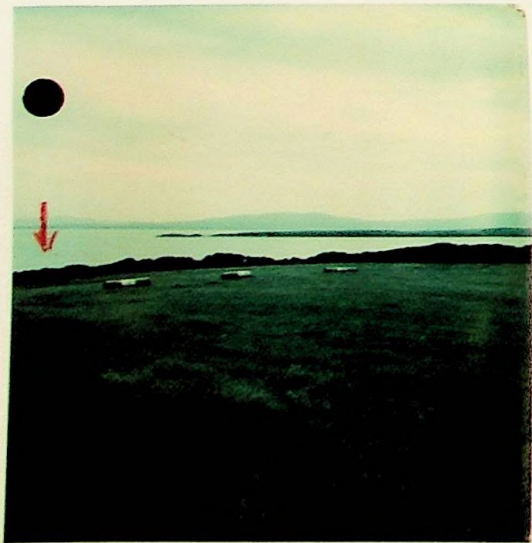
- 1/ North threshold and gorse hedge showing drum dislodged from threshold marker
- 2/ Area of gorse hedge in front of aircraft stop point.
- 3/ Damage to gorse by port engine and propeller.
