Accident to Beaver Aircraft

No. VPFAP 828.

Damage report on aircraft VP-BAF.

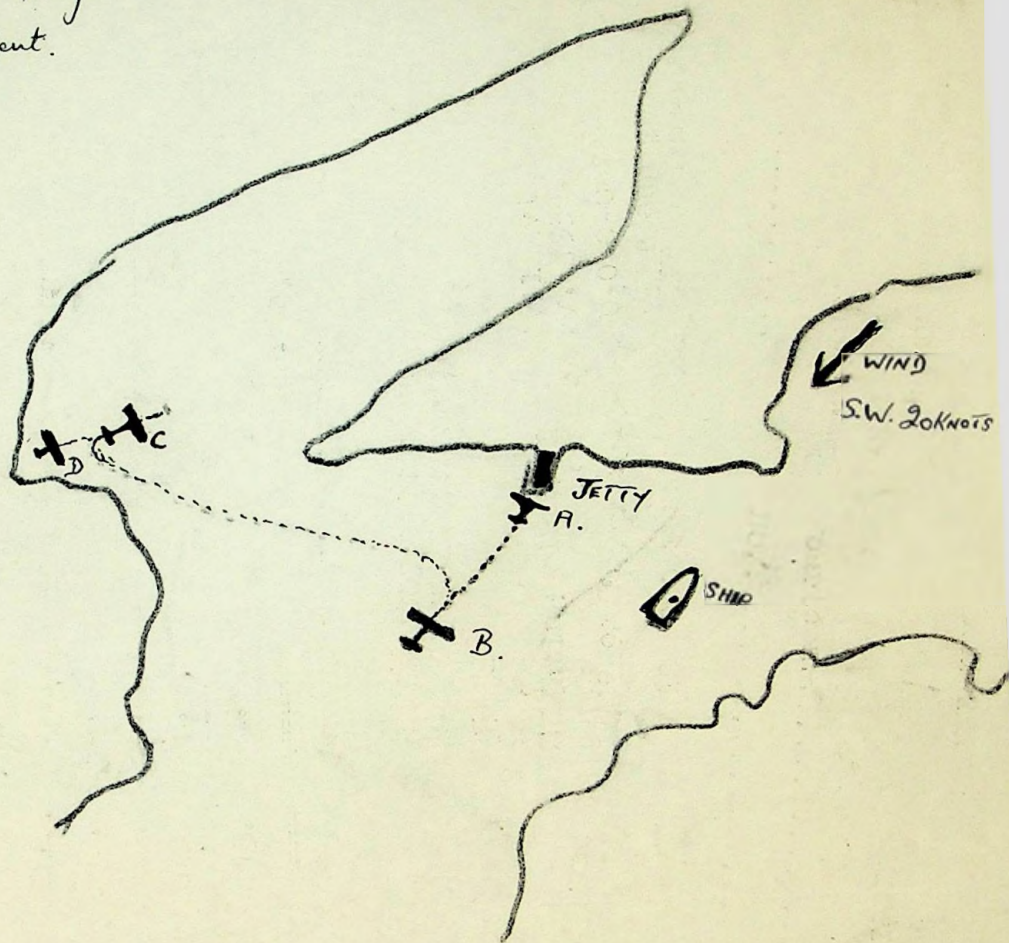
Rough Sketch showing positions of **afc** prior
after accident.

- "A." PLANE AT JETTY TO EMBARK PASSENGERS.
- "B." APPROX POSITION OF PLANE AFTER SAILING DOWNWIND FROM JETTY
- "C." APPROX POSITION OF PLANE AFTER TAXIING TO TAKE-OFF POINT.
- "D." PLANE AFTER CAPSIZING DRIFTED TO BEACH WHERE THE PASSENGERS WERE TAKEN ASHORE BY BOAT.

A. ALZIR, BOATMAN WITNESSED ACCIDENT AND ROWED BOAT FROM JETTY TO POSITION "D"
