FAKLAND ISLANDS GOVERNMENT AIR SERVICE.

ACCIDENT TO BEAVER AIRCRAFT VFFAH No. 1129.

Aircraft Accident Fitzroy 9/8/60.

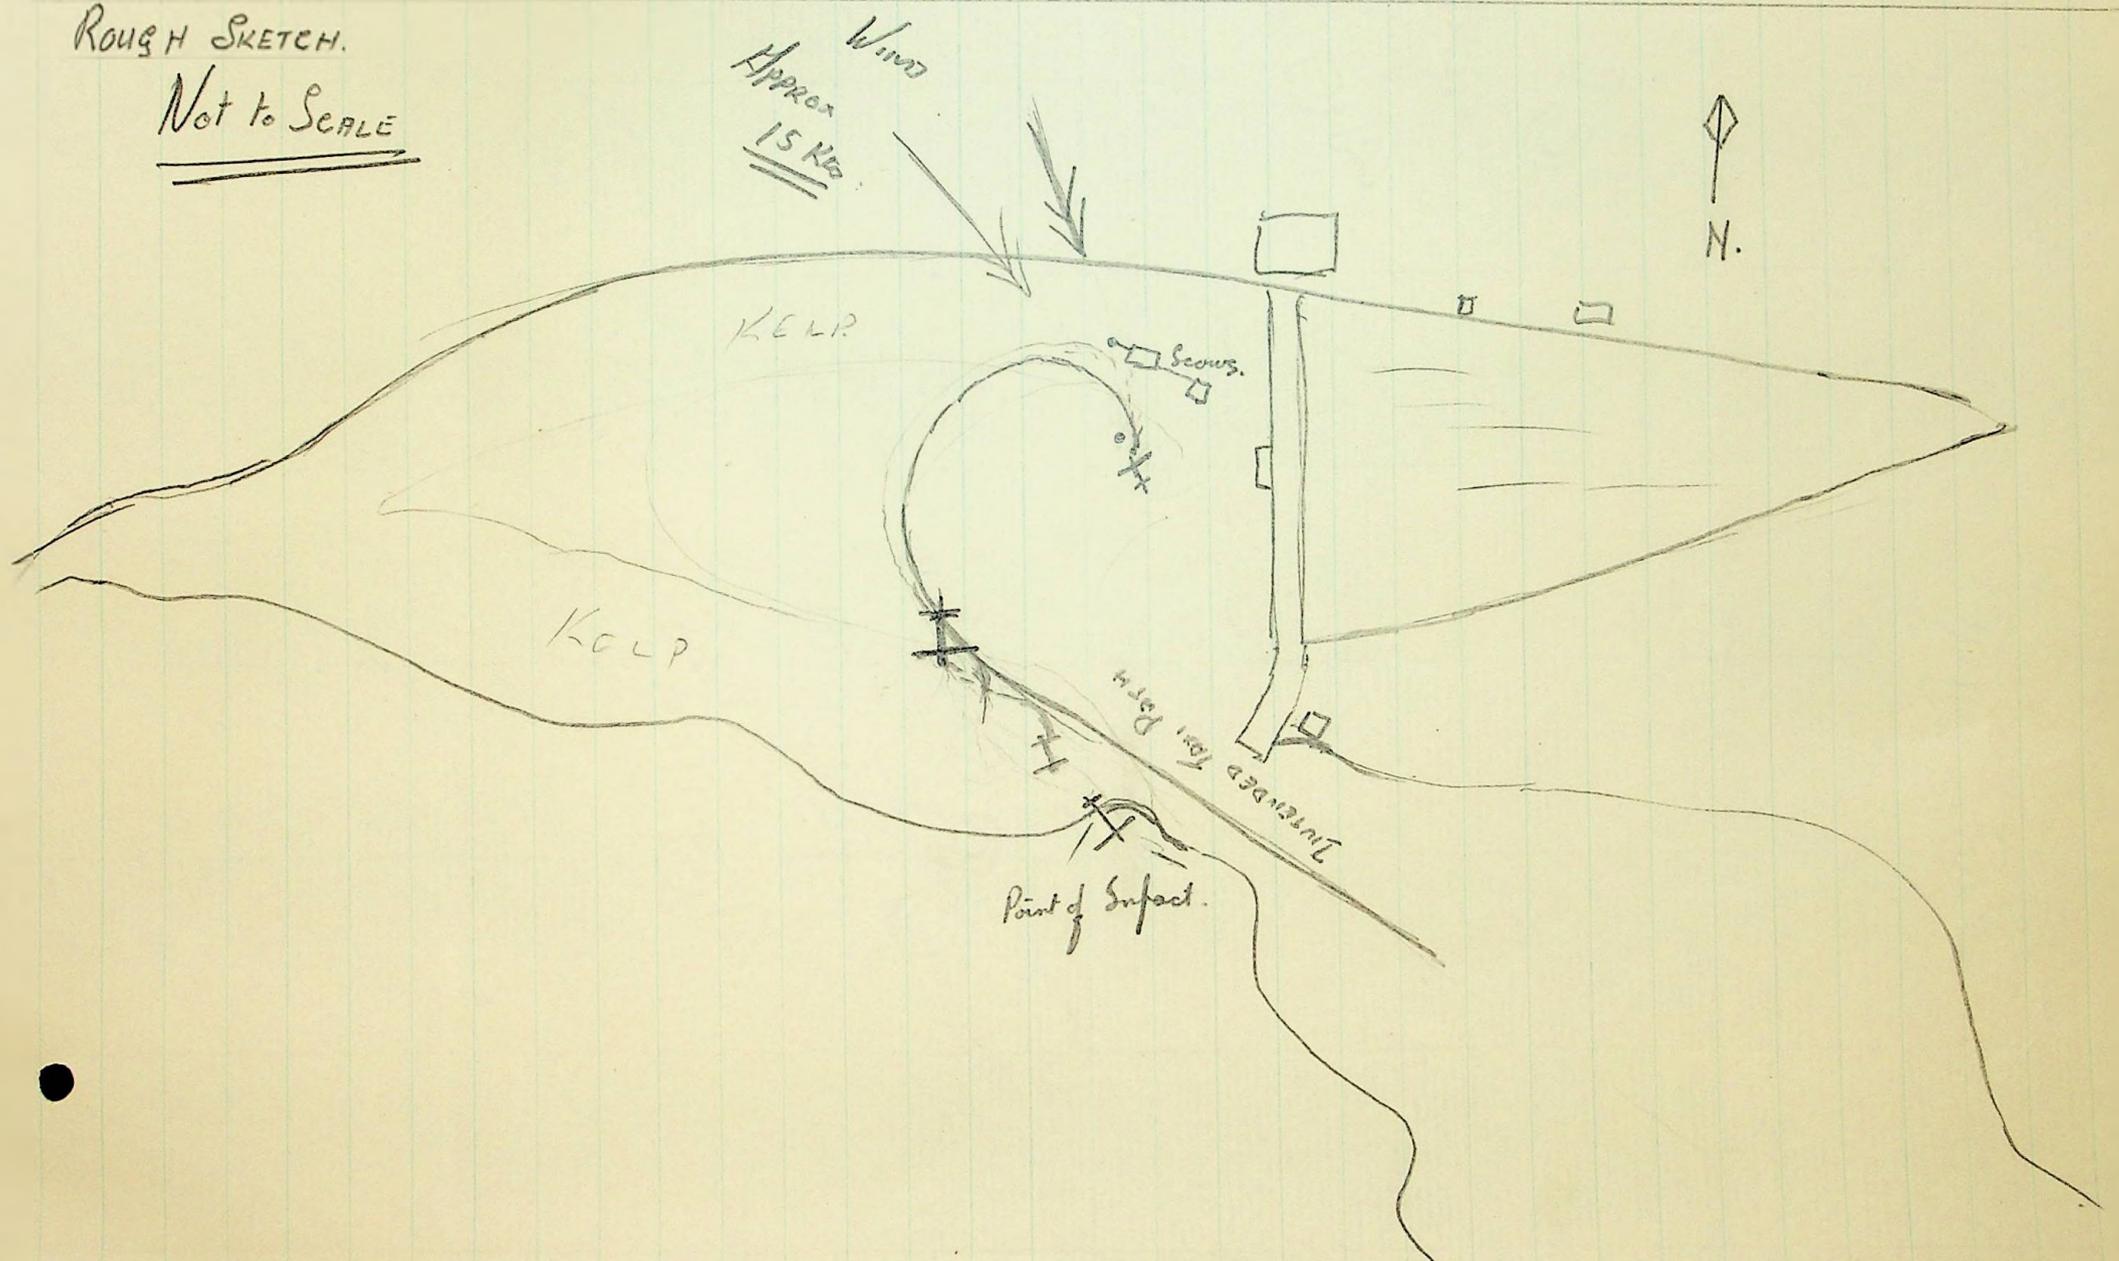
ROUGH SKETCH.
Not to Scale

- Q. What was the condition of the beach at the point of impact ?
- A. It was a steep rocky beach, and the type of beach which provides fairly deep water close inshore.
- Q. Why did you not drift to the harbour entrance ?
- A. Because there was a jetty within 50 yards of my tail onto which I would have drifted.
- Q. Why did you not turn to starboard when you slipped moorings ?
- A. Because there was insufficient manoeuvring space to complete a turn in that direction, and also because the turning arc of the aircraft is larger to starboard due to the torque reaction of the engine.
- Q. At what speed would you say the aircraft was travelling at the time of impact ?
- A. At about 15 knots.
