COLONIAL LIGHTS

CAPE PEMBROKE LIGHTHOUSE

MENGELARY POINT LIGHTHOUSE

on condition of lighthouse stations, following survey  
carried out during period 29th April, 1959, to 6th May,  
1959, with recommendations for improvements,

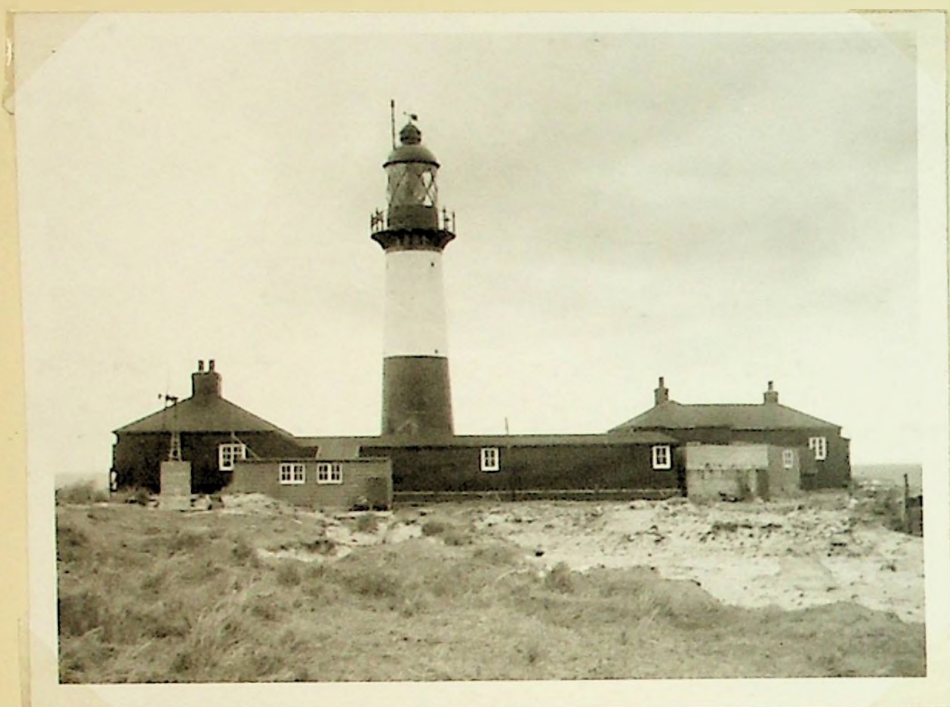
①

Dwelling accommodation is provided for the two resident keepers in single storey buildings sited adjacent to the tower. The station has no fog signal or radio beacon equipment. The lighthouse and dwellings are depicted on Plate 1.

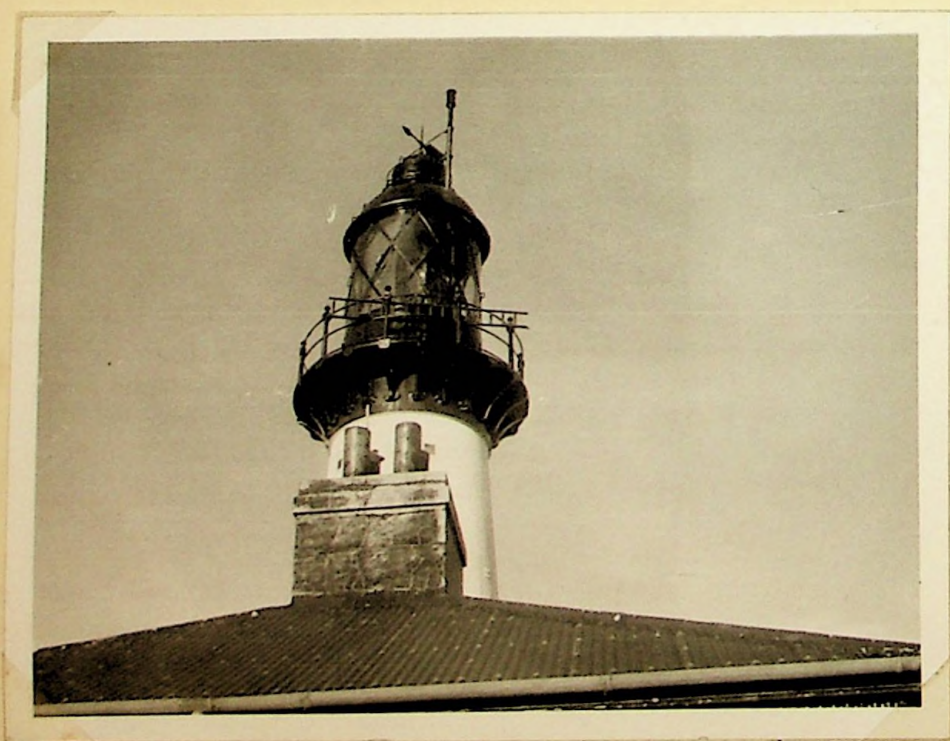
②

This is a standard 3rd Order lantern with gunmetal wind vane, copper ventilator, conical roof of steel plates with Tee bars, cill bar, dust plate and curtain rail, all in first class condition (see Plate 2). Very slight rusting has occurred at the bottom edge of two roof plates but no repairs are necessary. The ladder rail and brackets were in a dangerous condition but replacements have already been despatched to the lighthouse and should by now have been fitted. Gallery plating, cantilever supports and railings all in good condition.

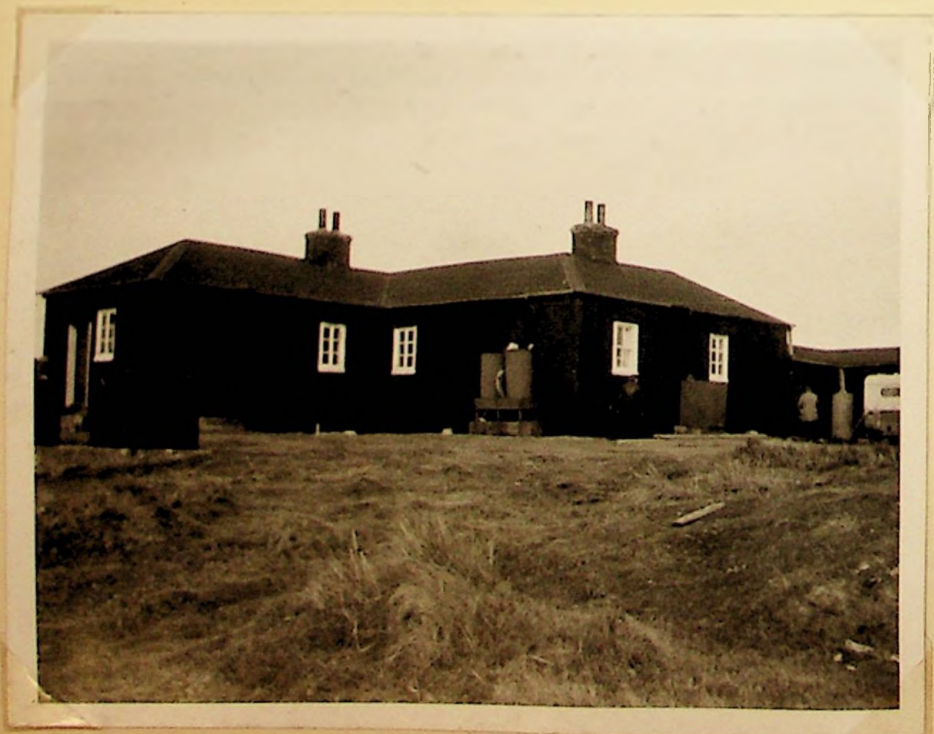
⑤

These quarters, which were constructed when the original tower was built, comprise a living room, two bedrooms, two store rooms and attached pantry, dairy, coal store, workshop and oil store (see Plate 5).

The structure is framed in steel with roof trusses and purlins all in good condition. Corrosion has, however, taken place at the eaves and where members are supported in the chimney brickwork. The roof is lined with timber and clad with Robertson's Protected Metal corrugated sheeting, all in fair condition; the roof lining having been replaced in one section. The roof is watertight. The sides of the buildings are lined with tongued and grooved boarding and clad externally with R.P.M. sheeting. This external sheeting is badly corroded at the bottom edges. The walls of the building are founded on concrete strip footings which, although cracked in many places have not noticeably subsided except in the case of the coal store where subsidence has taken place. The two brick chimneys, however, which are founded independently on concrete slabs have settled some 2" -  $2\frac{1}{2}$ " and have distorted the timber wall and ceiling

The dwellings are far too extensive, ugly in appearance, cold and affected by subsidence in parts. It is therefore recommended that new dwelling accommodation be provided on the lines shown on drawing No. 612/3 and 612/4, as explained later in this report.

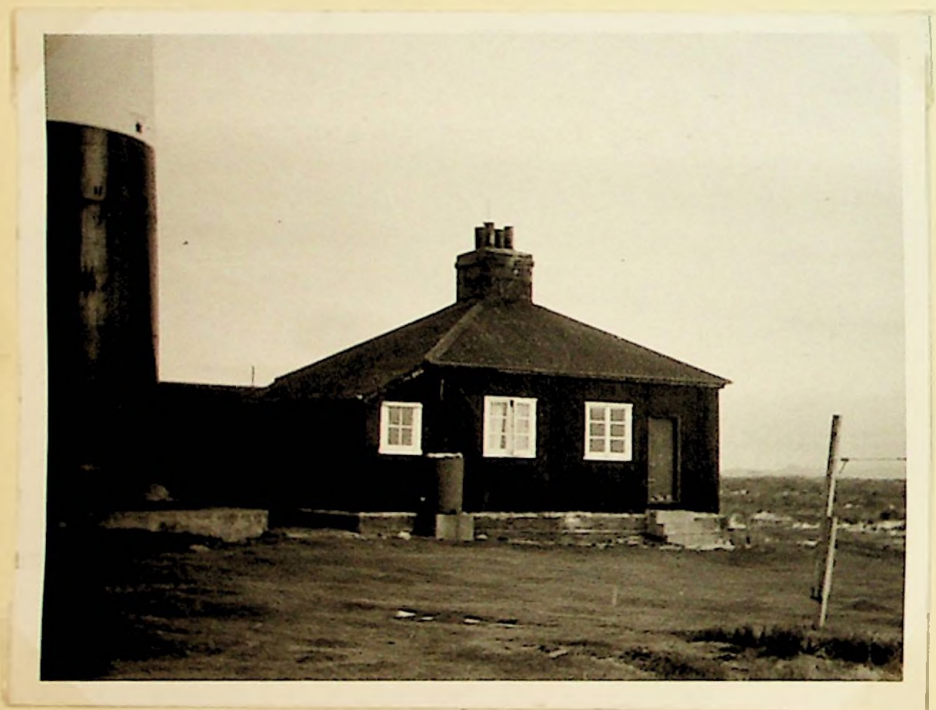
6

The Assistant Keeper's quarters were constructed when the tower was re-sited in its present position in 1906, and are more compact, providing living room accommodation, two bedrooms and bathroom - the bathroom being accessible only from the exterior (see Plate 6).

The quarters are framed in timber with roof trusses and purlins in first class condition. The roof, which is watertight, is lined with timber and clad with R.P.M., all in good condition.

The sides of the building are lined with tongued and grooved boarding and clad externally with R.P.M., which again is corroded at the bottom edges.

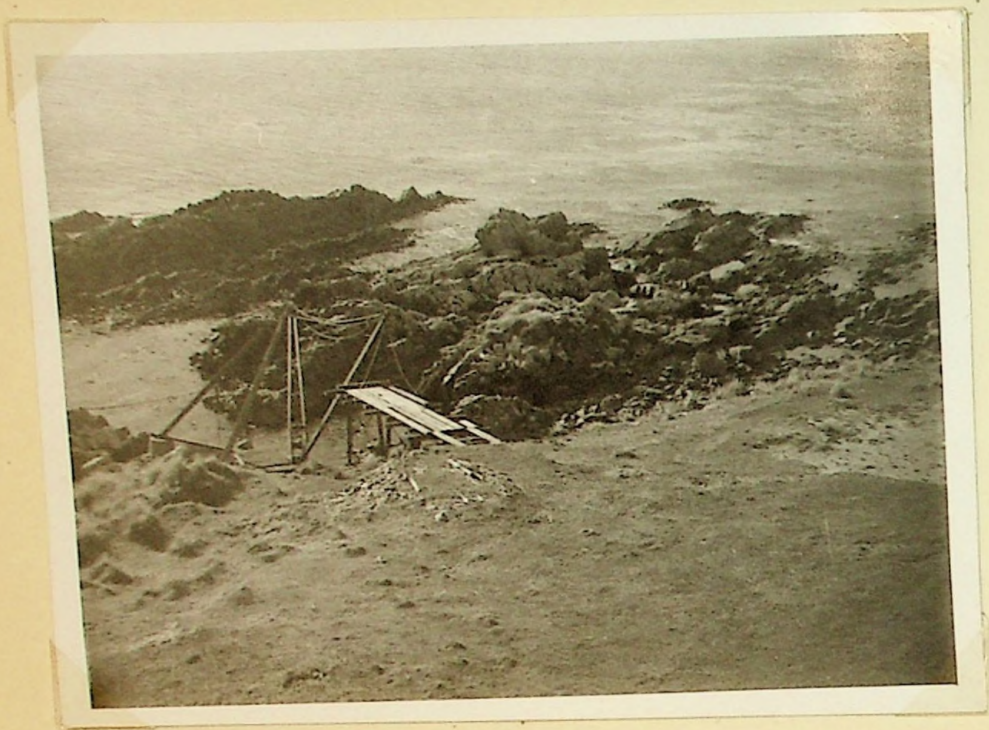
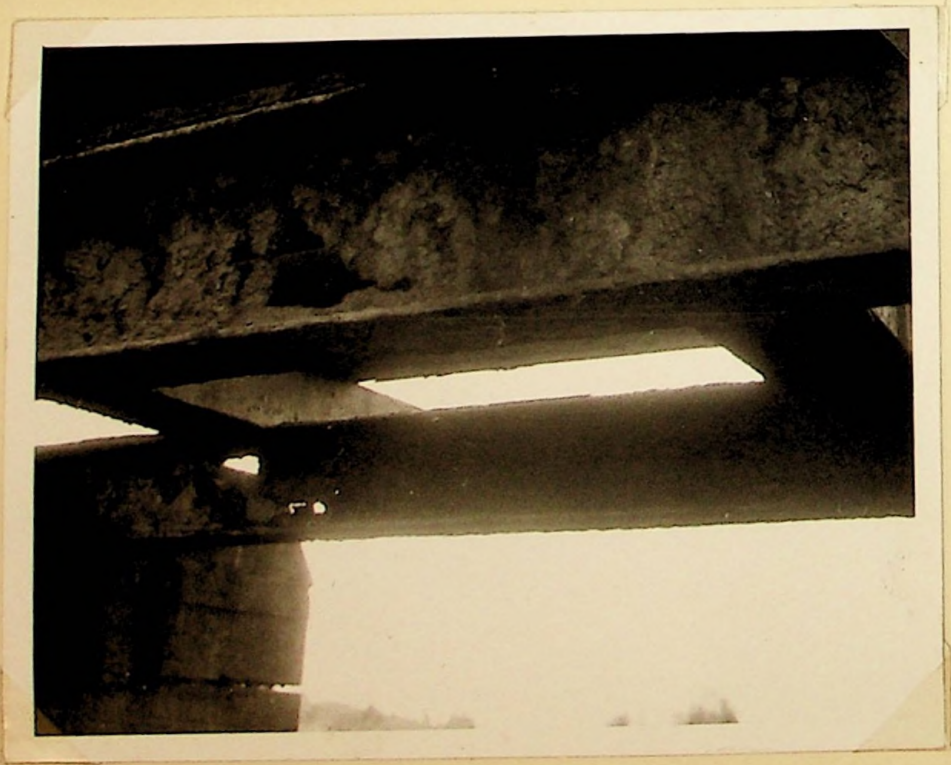
A landing stage was constructed out of steelworks salvaged from the original jetty, which was destroyed in a gale in 1906, and its use for landing materials or personnel has been discontinued for some time. Its condition is dangerous and complete demolition is recommended (see Plates 7 and 8).

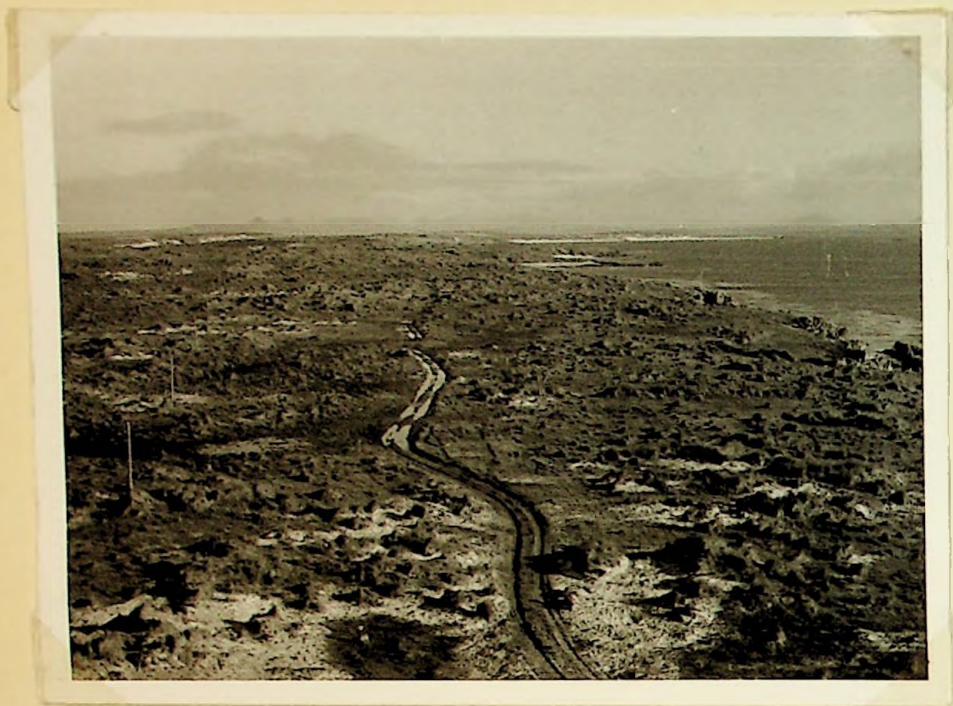
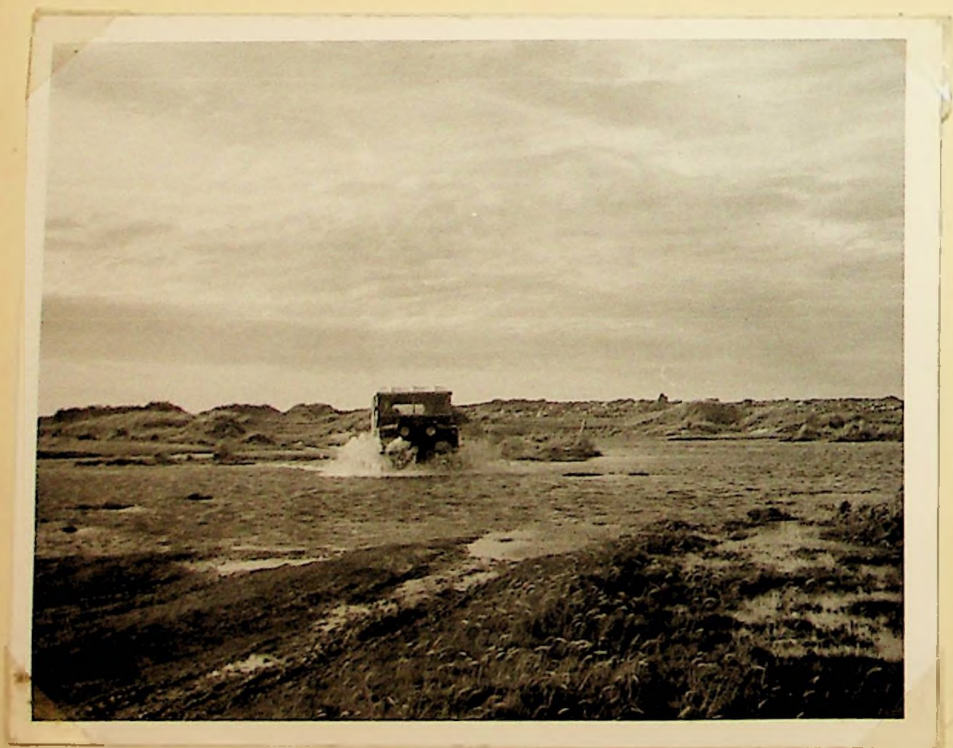
The access road from Port Stanley to the lighthouse is not a made road in any sense. It is merely a rough track over sandy and peaty areas, which entails negotiating sections which are under water at certain times (see Plates 9 and 10). The access is generally in very bad condition and some maintenance would appear to be essential. This would, however, by reason of economy, have to be restricted to filling in large potholes and re-grading the worst sections of the track. Access by the Landrover has, on the other hand, always been possible except on one occasion in the last seven years, but this is considered to be due to the skill of the driver and very rough usage of the vehicle.

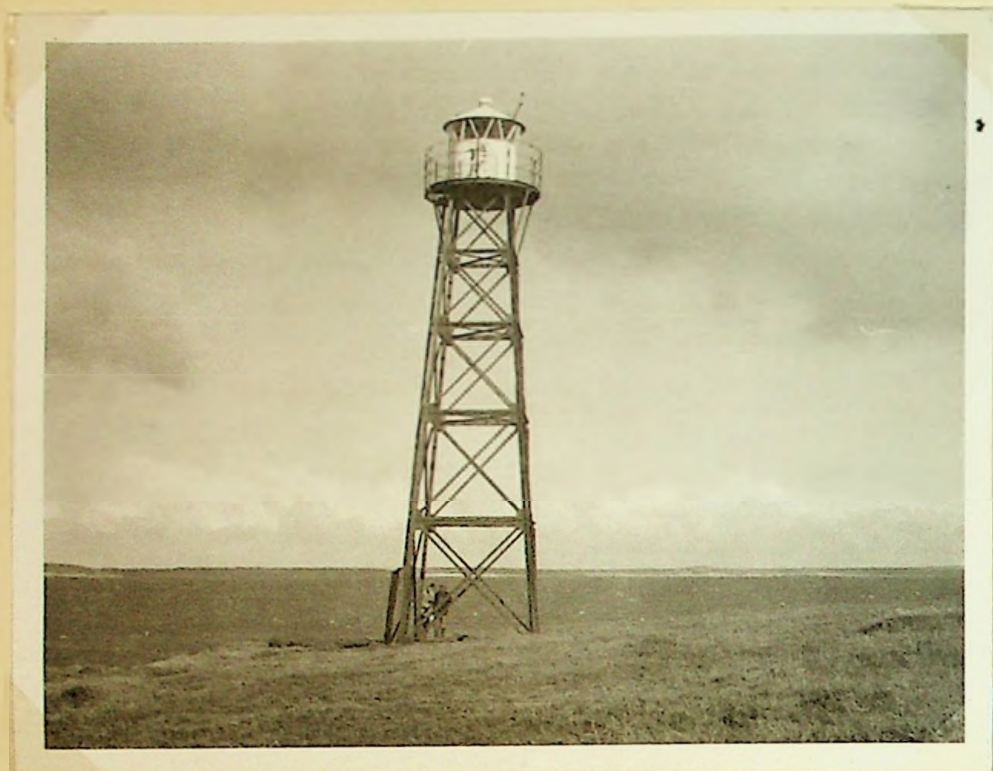
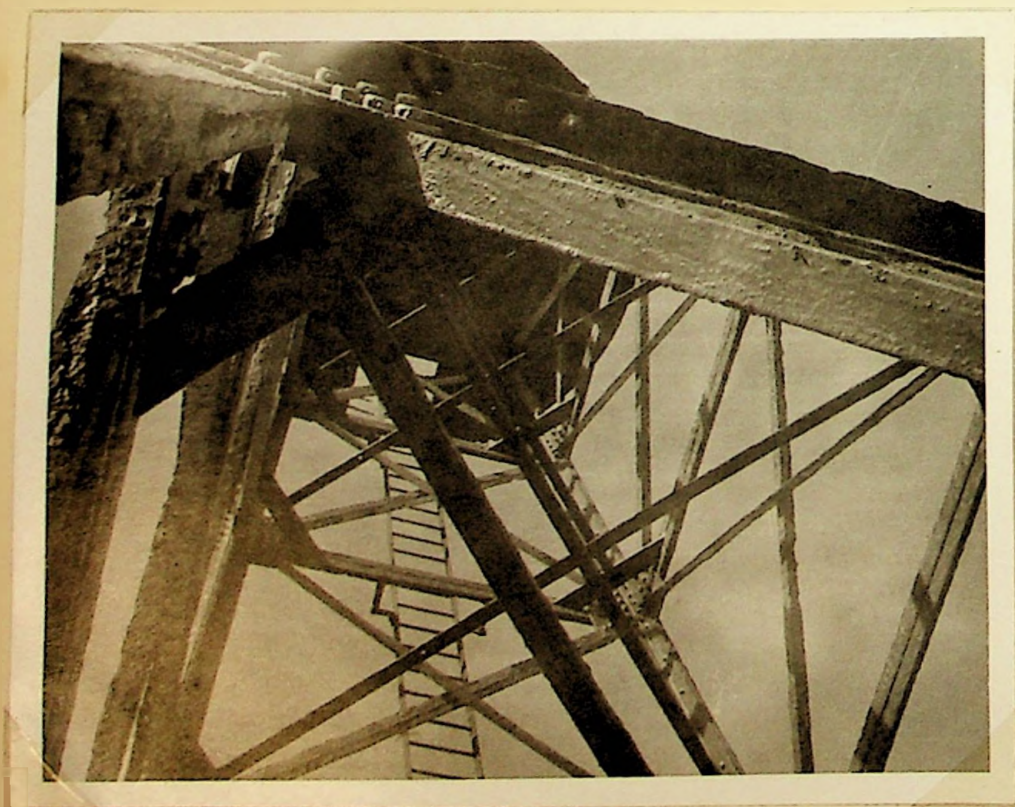
The lighthouse, depicted on Plates 11 and 12, comprises a steel lattice tower 44 ft. high from ground level to underside of lantern, surmounted by a lantern in which is housed an acetylene open flame burner, which exhibits a character of two white flashes every seven seconds. Operation of this flasher is by sun-valve located on the lantern roof.

The tower is of mild steel lattice construction with four corner legs bolted down to concrete foundation blocks by two 2" diameter holding down bolts per leg. The structural members are generally of angle section, the legs being double angles battened, and connections are riveted, or bolted. The whole of the steelwork is in an advanced stage of corrosion and many of the structural members are so reduced in effective cross sectional area that over stressing to serious proportions must obtain when strong wind forces are in action. The access ladder is also of mild steel and is attached to the tower at each level of cross bracings. The degree of corrosion, apart from other considerations, means that access is dangerous. No guard hoops are provided to the ladder and no intermediate platform is fitted. The lantern gallery steelwork and floor plating is in a very bad and dangerous condition. There is evidence of lack of adequate maintenance or protection by regular painting.

The lantern murette, glazing astragals and roof are of mild steel but apart from local areas of corrosion these are in fair condition, although rust removal, priming and painting is required urgently, to arrest further corrosion. Certain of the glazing capping strips are loose, the bolts having loosened and, in some instances, fallen out. The lantern glazing comprises 15 panes, twelve of which are cracked, and in two of these there are holes. The glazing is generally in a deplorable condition, although spares are housed inside the lantern, comprising one large and three small panes, all of which are serviceable. The sun-valve, which is fixed to the lantern roof by a steel bracket, appears to function but the bracket and gas piping are in bad condition.

The general condition of the steel tower, access ladder, lantern gallery and railings is such that any attempt to repair or renew sections of the steelwork would be extremely difficult and definitely uneconomical. The structure is considered to be dangerous and unsafe, and complete replacement is considered to be the only satisfactory solution. The lantern, however, together with the optic and flasher, can reasonably be salvaged and incorporated in any new proposals, which might take the form of a tubular steel tower, or perhaps precast concrete. New storage arrangements would also be necessary for the acetylene accumulators and this could take the form of a cabinet constructed in steel or timber. If mild steel is entertained for the new construction, all such material should be galvanised. Although the flasher is serviceable it is recommended that a replacement unit be provided immediately by the A.G.A. and the present one returned to them for full overhaul.
