COLONIAL LIGHTS

CAPE PEMBROKE LIGHTHOUSE

MENGEARY POINT LIGHTHOUSE

on condition of lighthouse stations, following survey
carried out during period 29th April, 1959, to 6th May,
1959, with recommendations for improvements,

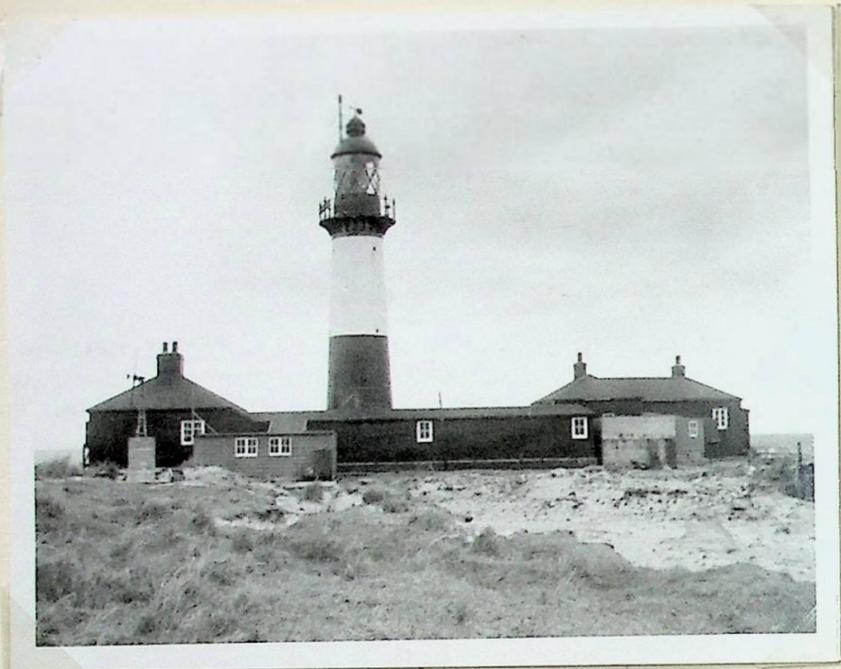
①

Dwelling accommodation is provided for the two resident keepers in single storey buildings sited adjacent to the tower. The station has no fog signal or radio beacon equipment. The lighthouse and dwellings are depicted on Plate 1.

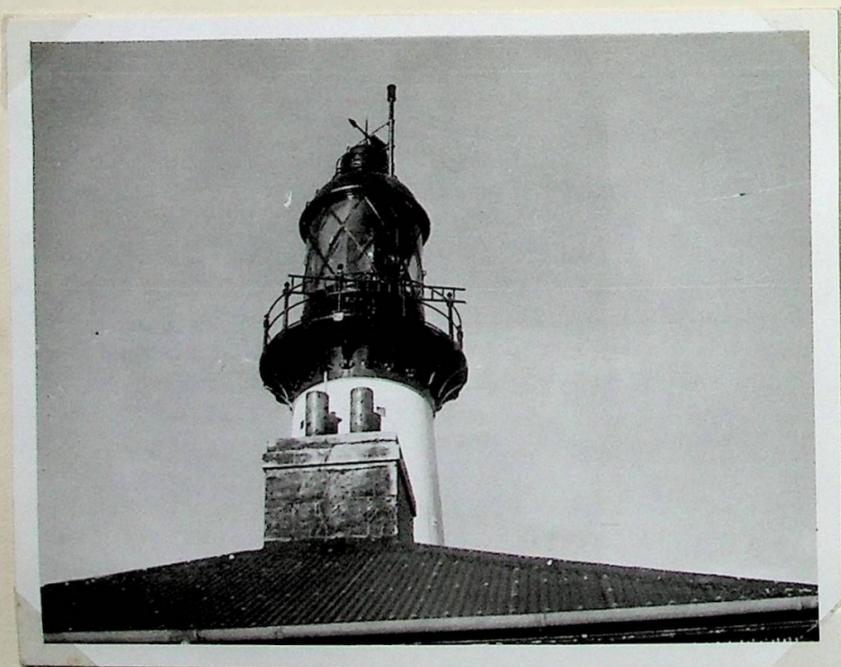
②

This is a standard 3rd Order lantern with gunmetal wind vane, copper ventilator, conical roof of steel plates with Tee bars, cill bar, dust plate and curtain rail, all in first class condition (see Plate 2). Very slight rusting has occurred at the bottom edge of two roof plates but no repairs are necessary. The ladder rail and brackets were in a dangerous condition but replacements have already been despatched to the lighthouse and should by now have been fitted. Gallery plating, cantilever supports and railings all in good condition.

The glazing astragals are of steel and in good condition and the glass, with the exception of one full diamond, has no cracks or chips. The one damaged panel of glass requires replacing because of two cracks in the bottom corner. The whole of the glazing is in serviceable condition, although re-puttying is required internally. At the date of survey there were only two half diamond spare panels, but recently three full and one half diamond have been despatched to the station.

The lantern murette is constructed in one tier in cast iron and steel with gunmetal access door to gallery. All is in good condition with the exception of the slam plate to the access

door which is cracked and bent. This item requires replacing to facilitate proper closure of the door. There is a disused flue pipe from the service room beneath and this is badly holed and requires removing. As a result, appropriate steel patch plates will be required to seal the apertures thus exposed in the lantern roof and floor.

- (i) Remove flue pipe in lantern and stove in service room and fit patch plates to lantern roof and floor.
- (ii) Remove worn and defective slam plate from lantern door to gallery and fit new brass plate.

- (v) Take out one full diamond, with crack in corner, in lantern glazing and replace with new panel from station spares.
- (vi) Take out 2 No. cracked panes of glass in tower windows and replace by 32 oz. clear glass obtained locally.

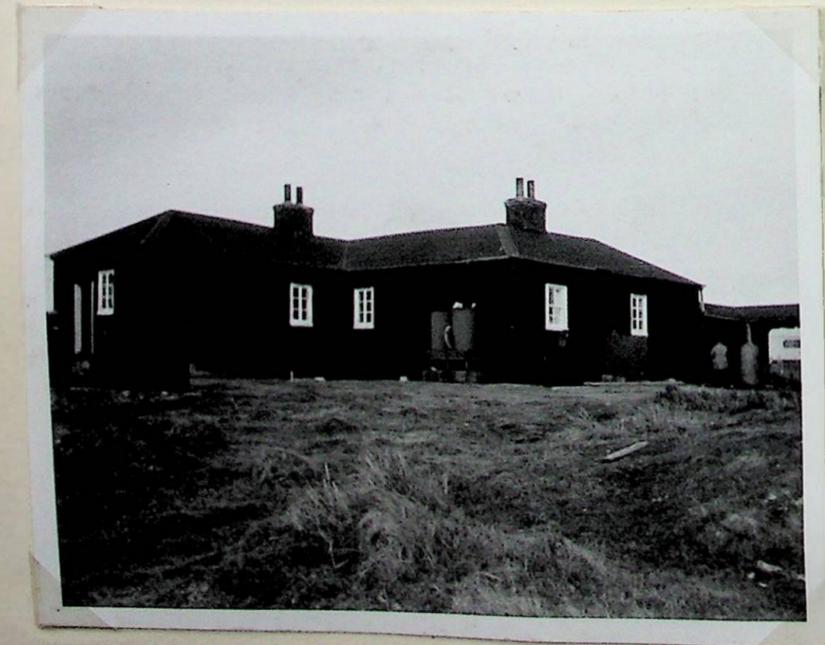
⑤

These quarters, which were constructed when the original tower was built, comprise a living room, two bedrooms, two store rooms and attached pantry, dairy, coal store, workshop and oil store (see Plate 5).

The structure is framed in steel with roof trusses and purlins all in good condition. Corrosion has, however, taken place at the eaves and where members are supported in the chimney brickwork. The roof is lined with timber and clad with Robertson's Protected Metal corrugated sheeting, all in fair condition; the roof lining having been replaced in one section. The roof is watertight. The sides of the buildings are lined with tongued and grooved boarding and clad externally with R.P.M. sheeting. This external sheeting is badly corroded at the bottom edges. The walls of the building are founded on concrete strip footings which, although cracked in many places have not noticeably subsided except in the case of the coal store where subsidence has taken place. The two brick chimneys, however, which are founded independently on concrete slabs have settled some $2'' - 2\frac{1}{2}''$ and have distorted the timber wall and ceiling

linings attached to them. Also the floors have pronounced inclinations towards the fireplaces. The Cornish Range in the kitchen is badly cracked and is little used. All of the rooms are wired for electric lighting, which was originally powered by a windmill generator, installed during the last war. This generator, however, has been removed and power for these lighting points is not at present available.

The dwellings are far too extensive, ugly in appearance, cold and affected by subsidence in parts. It is therefore recommended that new dwelling accommodation be provided on the lines shown on drawing No. 612/3 and 612/4, as explained later in this report.

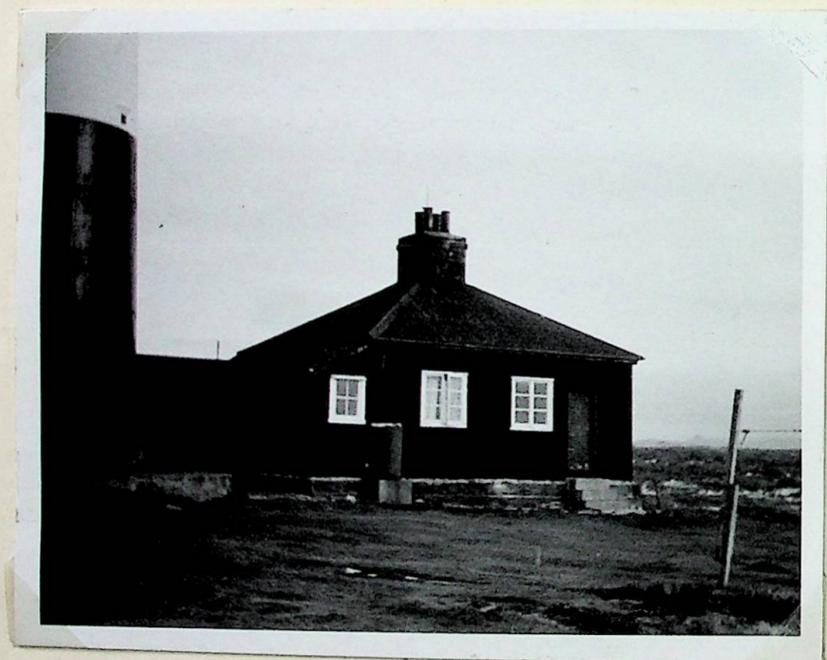
6

The Assistant Keeper's quarters were constructed when the tower was re-sited in its present position in 1906, and are more compact, providing living room accommodation, two bedrooms and bathroom - the bathroom being accessible only from the exterior (see Plate 6).

The quarters are framed in timber with roof trusses and purlins in first class condition. The roof, which is watertight, is lined with timber and clad with R.P.M., all in good condition.

The sides of the building are lined with tongued and grooved boarding and clad externally with R.P.M., which again is corroded at the bottom edges.

Again the walls are founded on concrete strip footings and the chimney brickwork independently on a concrete slab. In this instance, however, no settlement has taken place, and all foundations are in good condition. The kitchen, bedrooms and pantry are wired for electric lights which are not in use.

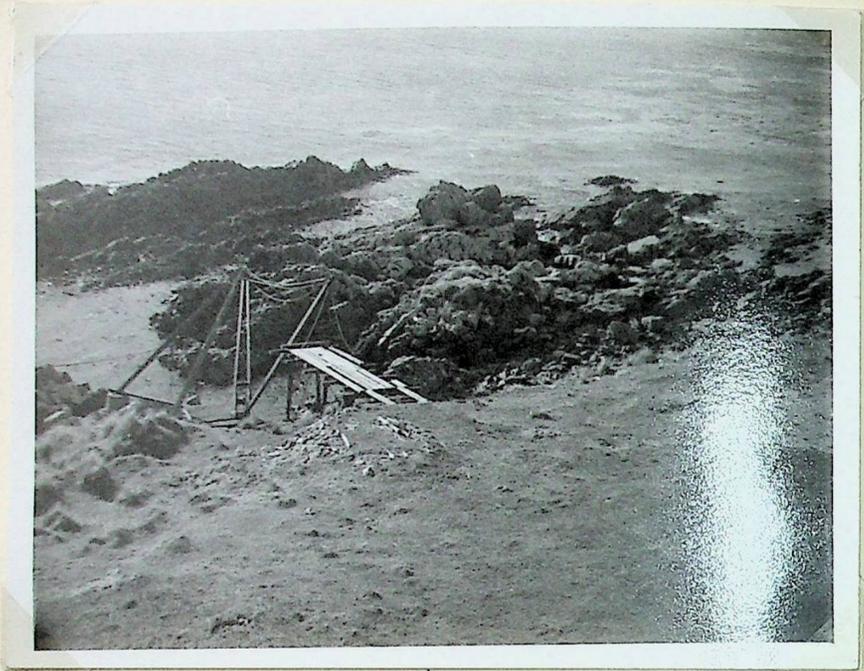
A landing stage was constructed out of steelworks salvaged from the original jetty, which was destroyed in a gale in 1906, and its use for landing materials or personnel has been discontinued for some time. Its condition is dangerous and complete demolition is recommended (see Plates 7 and 8).

A 20 cwt capacity jib crane is situated alongside the sea below the landing stage, and it is of timber construction, supported on masonry piers. The crane is provided with a 40 ft. jib and is for hand operation only. It has not been used for some considerable time, and its general condition is such that renovation costs would be prohibitive economically, if consideration were given to its re-siting. Complete demolition is recommended.

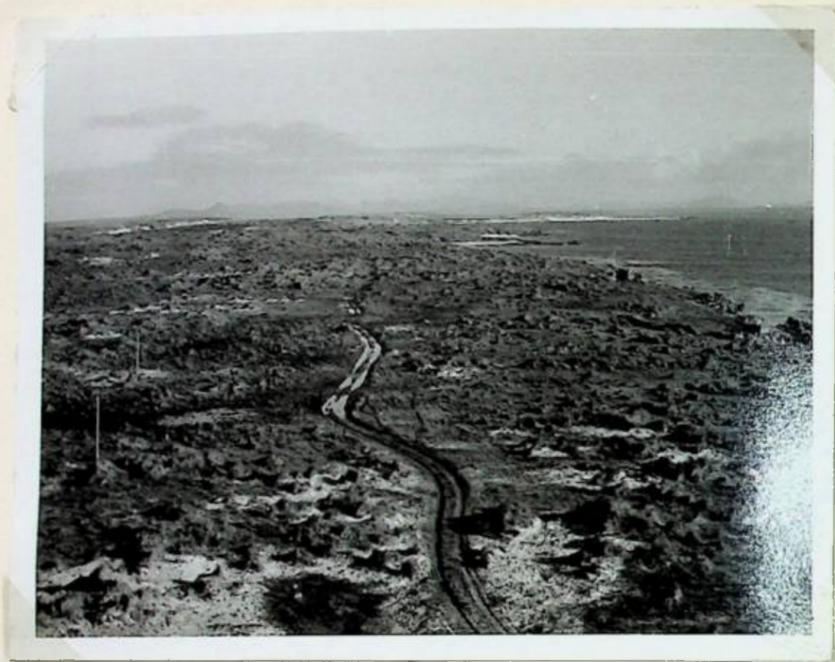
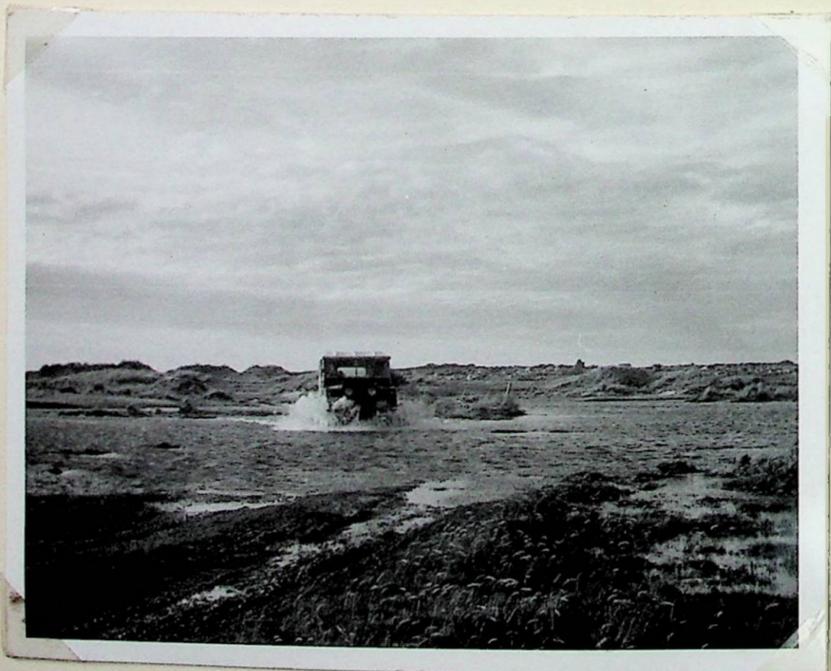
The access road from Port Stanley to the lighthouse is not a made road in any sense. It is merely a rough track over sandy and peaty areas, which entails negotiating sections which are under water at certain times (see Plates 9 and 10). The access is generally in very bad condition and some maintenance would appear to be essential. This would, however, by reason of economy, have to be restricted to filling in large potholes and re-grading the worst sections of the track. Access by the Landrover has, on the other hand, always been possible except on one occasion in the last seven years, but this is considered to be due to the skill of the driver and very rough usage of the vehicle.

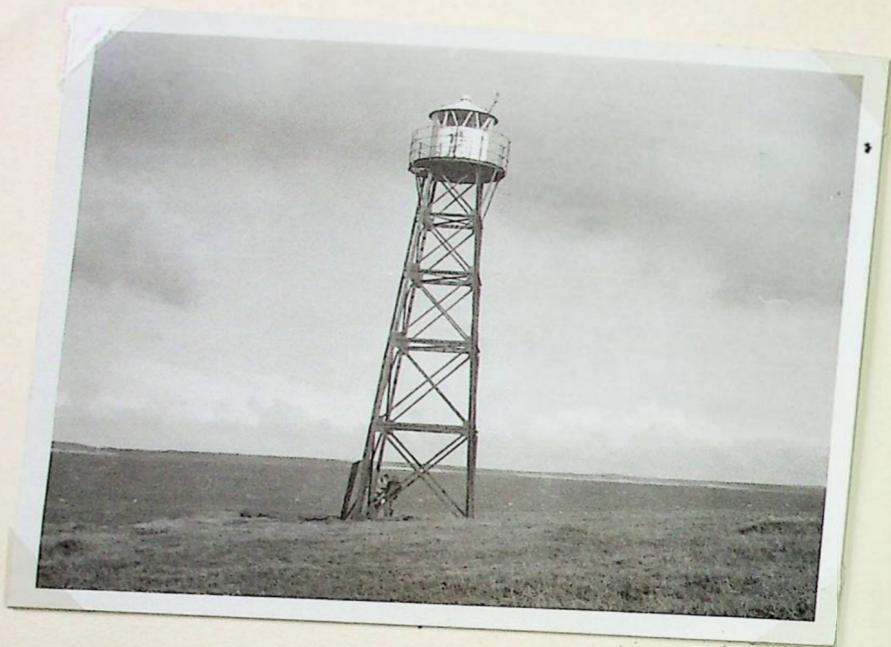
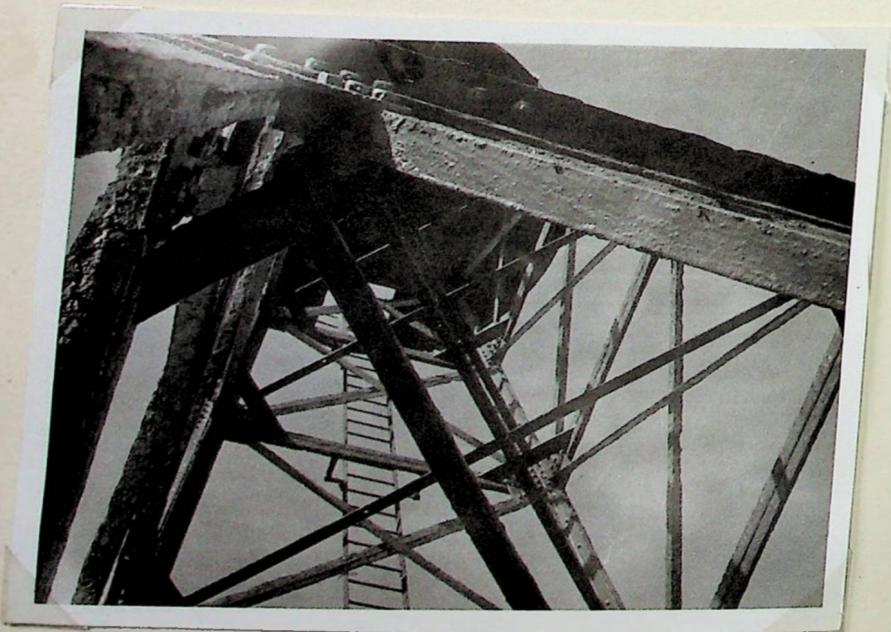
The lighthouse, depicted on Plates 11 and 12, comprises a steel lattice tower 44 ft. high from ground level to underside of lantern, surmounted by a lantern in which is housed an acetylene open flame burner, which exhibits a character of two white flashes every seven seconds. Operation of this flasher is by sun-valve located on the lantern roof.

The tower is of mild steel lattice construction with four corner legs bolted down to concrete foundation blocks by two 2" diameter holding down bolts per leg. The structural members are generally of angle section, the legs being double angles battened, and connections are riveted, or bolted. The whole of the steelwork is in an advanced stage of corrosion and many of the structural members are so reduced in effective cross sectional area that over stressing to serious proportions must obtain when strong wind forces are in action. The access ladder is also of mild steel and is attached to the tower at each level of cross bracings. The degree of corrosion, apart from other considerations, means that access is dangerous. No guard hoops are provided to the ladder and no intermediate platform is fitted. The lantern gallery steelwork and floor plating is in a very bad and dangerous condition. There is evidence of lack of adequate maintenance or protection by regular painting.

The lantern murette, glazing astragals and roof are of mild steel but apart from local areas of corrosion these are in fair condition, although rust removal, priming and painting is required urgently, to arrest further corrosion. Certain of the glazing capping strips are loose, the bolts having loosened and, in some instances, fallen out. The lantern glazing comprises 15 panes, twelve of which are cracked, and in two of these there are holes. The glazing is generally in a deplorable condition, although spares are housed inside the lantern, comprising one large and three small panes, all of which are serviceable. The sun-valve, which is fixed to the lantern roof by a steel bracket, appears to function but the bracket and gas piping are in bad condition.

This cupboard is of mild steel and is fixed to the tower steelwork at the base. Housed inside are 6 No. A50 gas accumulators, which are all coupled to one common supply line. The cabinet is severely corroded and the pipework and unions are also corroded and in a bad condition.

The general condition of the steel tower, access ladder, lantern gallery and railings is such that any attempt to repair or renew sections of the steelwork would be extremely difficult and definitely uneconomical. The structure is considered to be dangerous and unsafe, and complete replacement is considered to be the only satisfactory solution. The lantern, however, together with the optic and flasher, can reasonably be salvaged and incorporated in any new proposals, which might take the form of a tubular steel tower, or perhaps precast concrete. New storage arrangements would also be necessary for the acetylene accumulators and this could take the form of a cabinet constructed in steel or timber. If mild steel is entertained for the new construction, all such material should be galvanised. Although the flasher is serviceable it is recommended that a replacement unit be provided immediately by the A.G.A. and the present one returned to them for full overhaul.
