FALKLAND ISLANDS

CAPE PEMBROKE LIGHTHOUSE

NAVIGATION AIDS IN PORT WILLIAM

CIVIL SECTION,
ENGINEER-IN-CHIEF'S DEPARTMENT,
TRINITY HOUSE.

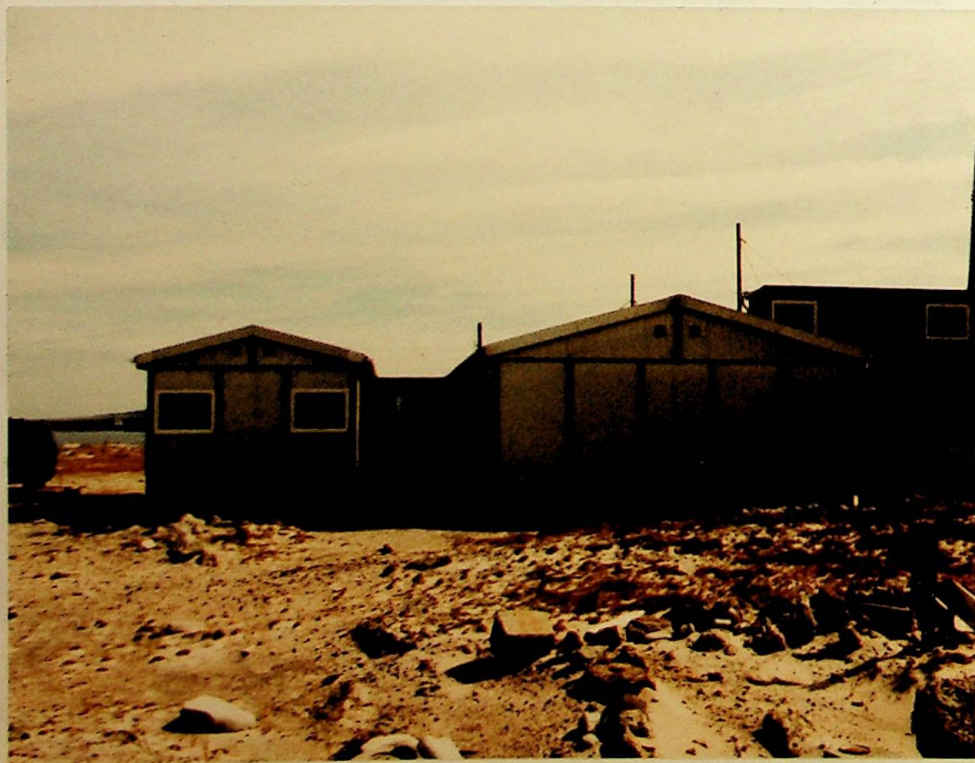
-04

Structurally, the dwellings being of a prefabricated aluminium construction appear sound for their age.

Otherwise, they have been the subject of neglect and vandalism during the last eighteen months, with entrance doors pulled off their hinges, windows smashed, fixtures and fittings removed or broken, the walls and ceilings filthy and the floors littered with debris.

DWELLINGS

It is therefore recommended that these buildings be demolished, and alternative provision made for generators and batteries required for electrification of the light.

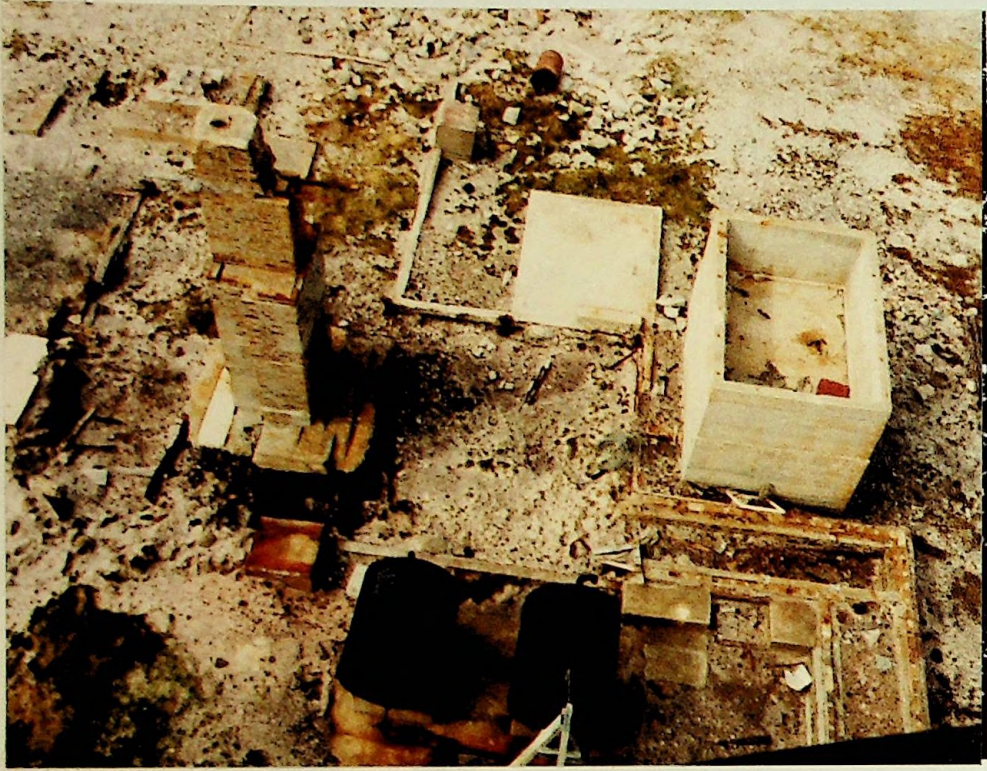
- 07

The area has a general appearance of untidiness, partly due to neglected fences, disused telegraph poles, and the foundations and rubble from a previous lighthouse dwelling, but also due to more recent abandoned equipment and excavations for defensive positions.

REMAINS OF PREVIOUS DWELLINGS

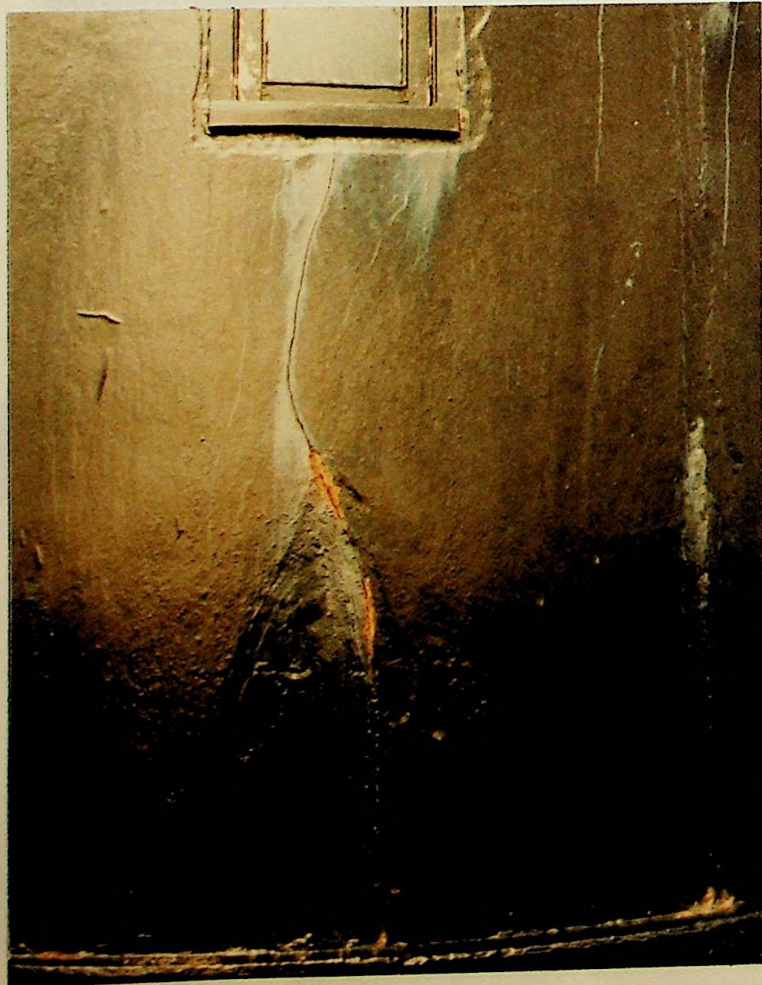
- 08

The tower appears structurally sound apart from one major and one minor crack visible in the base section.

This cracking appears to have been present for some considerable time, and is repairable.

The two cracks mentioned above are visible within the tower, a minor one in segment No. 5 running for about 250mm vertically of hairline width, the second, more serious crack running from the shaped collar on the exterior of the tower to the underside of one window, being about 2mm in width.

CRACK IN TOWER BASE

The tower requires cleaning and painting internally and externally, and the crack in the base repaired.

Repair plates will have to be fitted to the cracks in the base section of the tower.

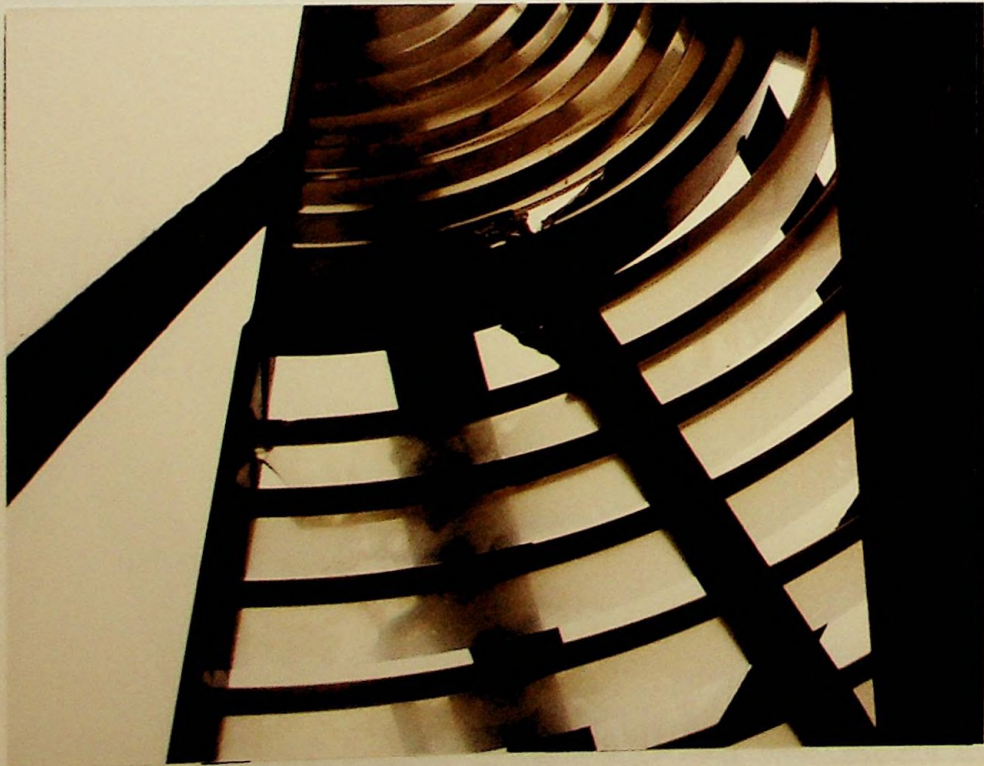
-10

A bullet hole can be observed in one of the glazing diamonds. Some damage has occurred to the prisms on the optic also caused by the same projectile. Additionally one of the upper half diamonds is cracked. Not 2.

BROKEN PRISMS IN OPTIC

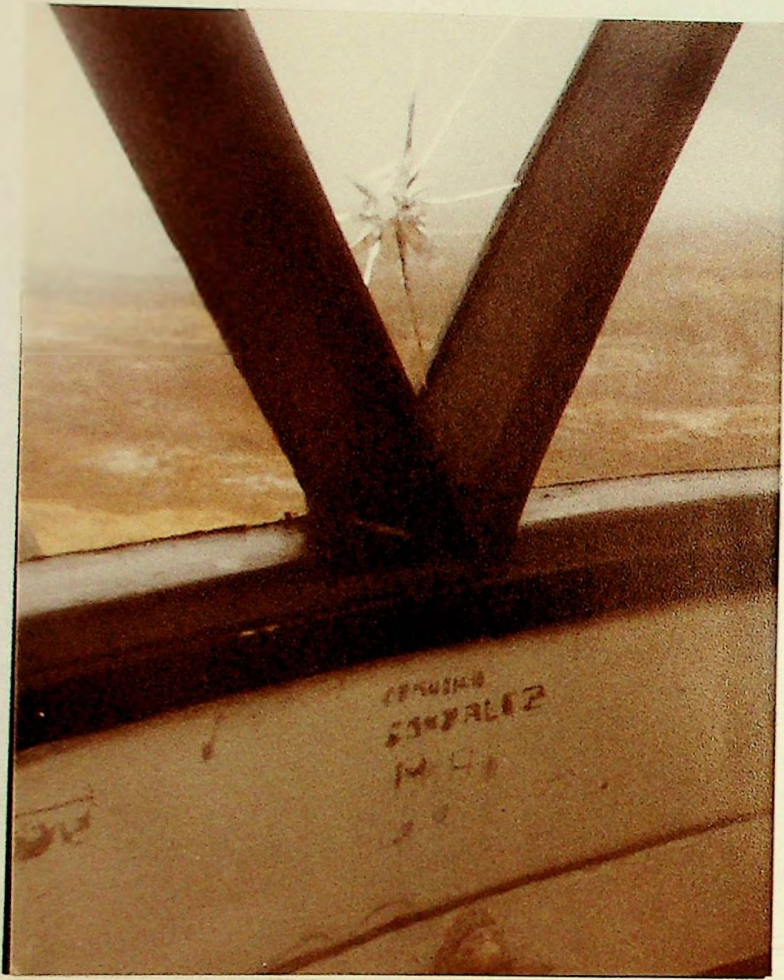
-11

BULLET HOLE IN LANTERN GLAZING

Some additional minor repairs are necessary to replace missing hinges and murette ventilator knobs, mend the timber storage cupboard, and replace the two broken panels of lantern glazing.

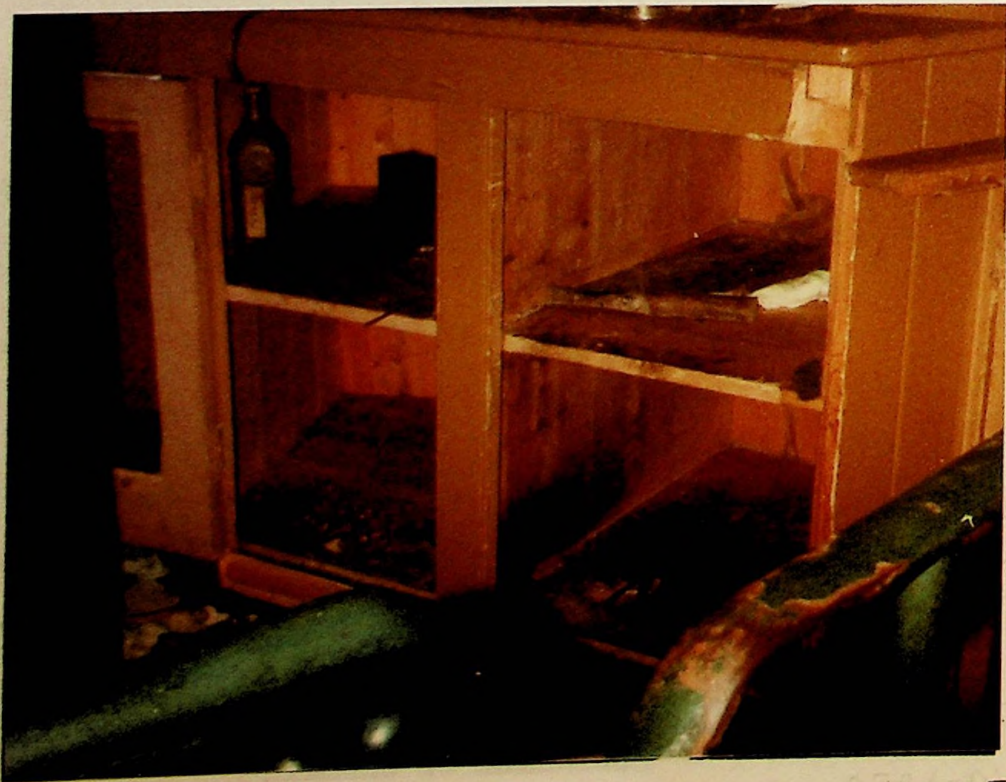
-12

A timber storage cupboard is located in this room. The doors have been smashed and part of the carcass damaged, but on the whole it is sound and repairable.

SMASHED STORE CUPBOARD

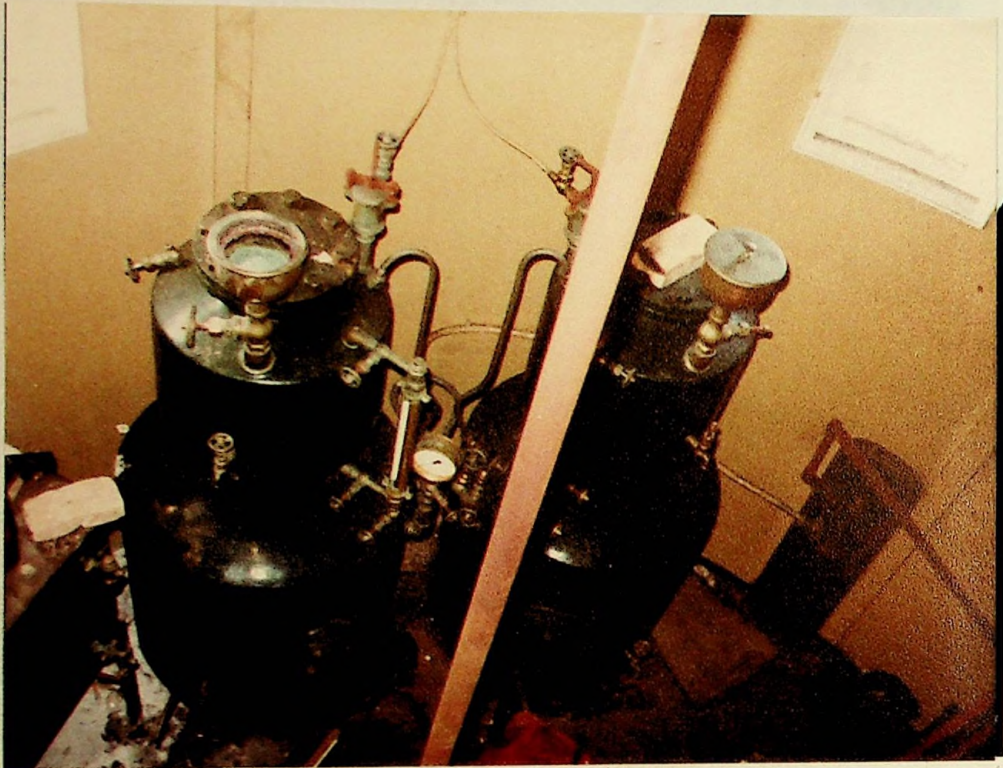
-13

Some fittings have been removed from the pressure vessels and the clock mechanism, and steel parts of the vessels and clock are rusting.

PRESSURE VESSELS IN SERVICE ROOM

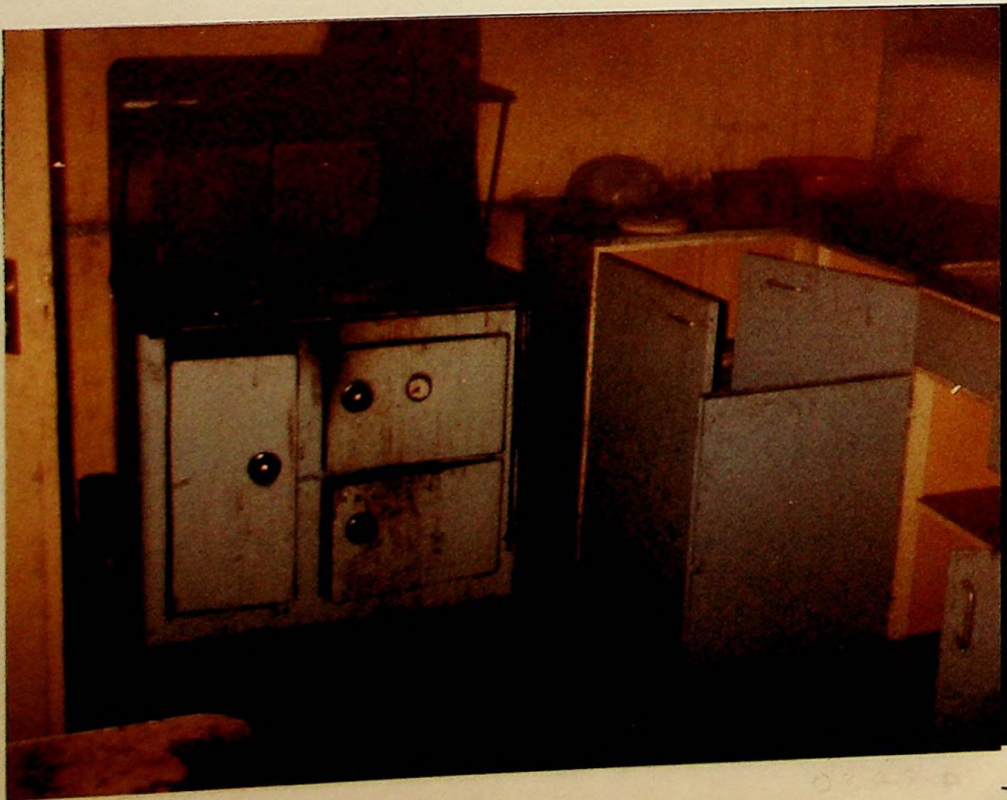
-14

KITCHEN IN DWELLINGS

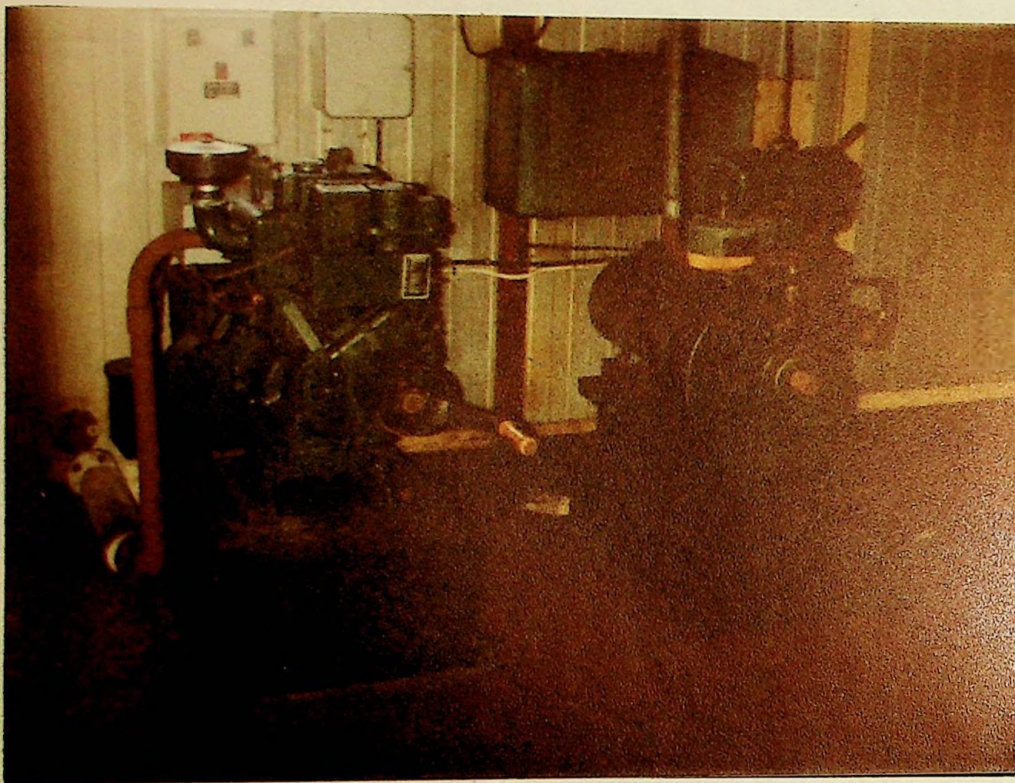
-15

These are two diesel generating sets, an old Petter PAZ1 with a BKB 1.2 kVA generator, which proved unreliable leading to the addition of a Lister ST1 with a Brush 3.5 kVA generator which appeared in good condition, but could not be started as the fuel feed lines had been cut, and the oil tanks had been drained. gone

GENERATOR SETS

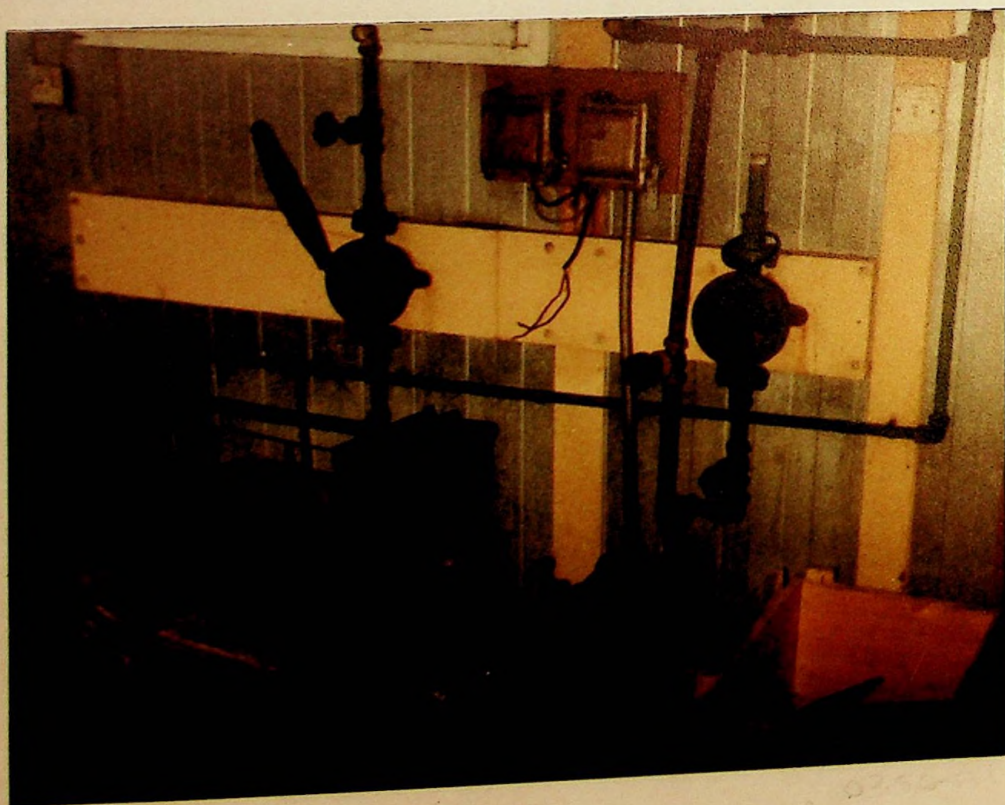
-16

The Engine Room is in very poor condition. Most equipment has been vandalised and is rusting, wiring has been pulled away from connections, electrical fittings smashed, and spares and tools scattered about the room.

ENGINE ROOM
