FALKLAND ISLANDS

A Report on the
Stanley Potable and
Fire-Fighting Water
Supply Systems

Ref. Q367/44
March 1977

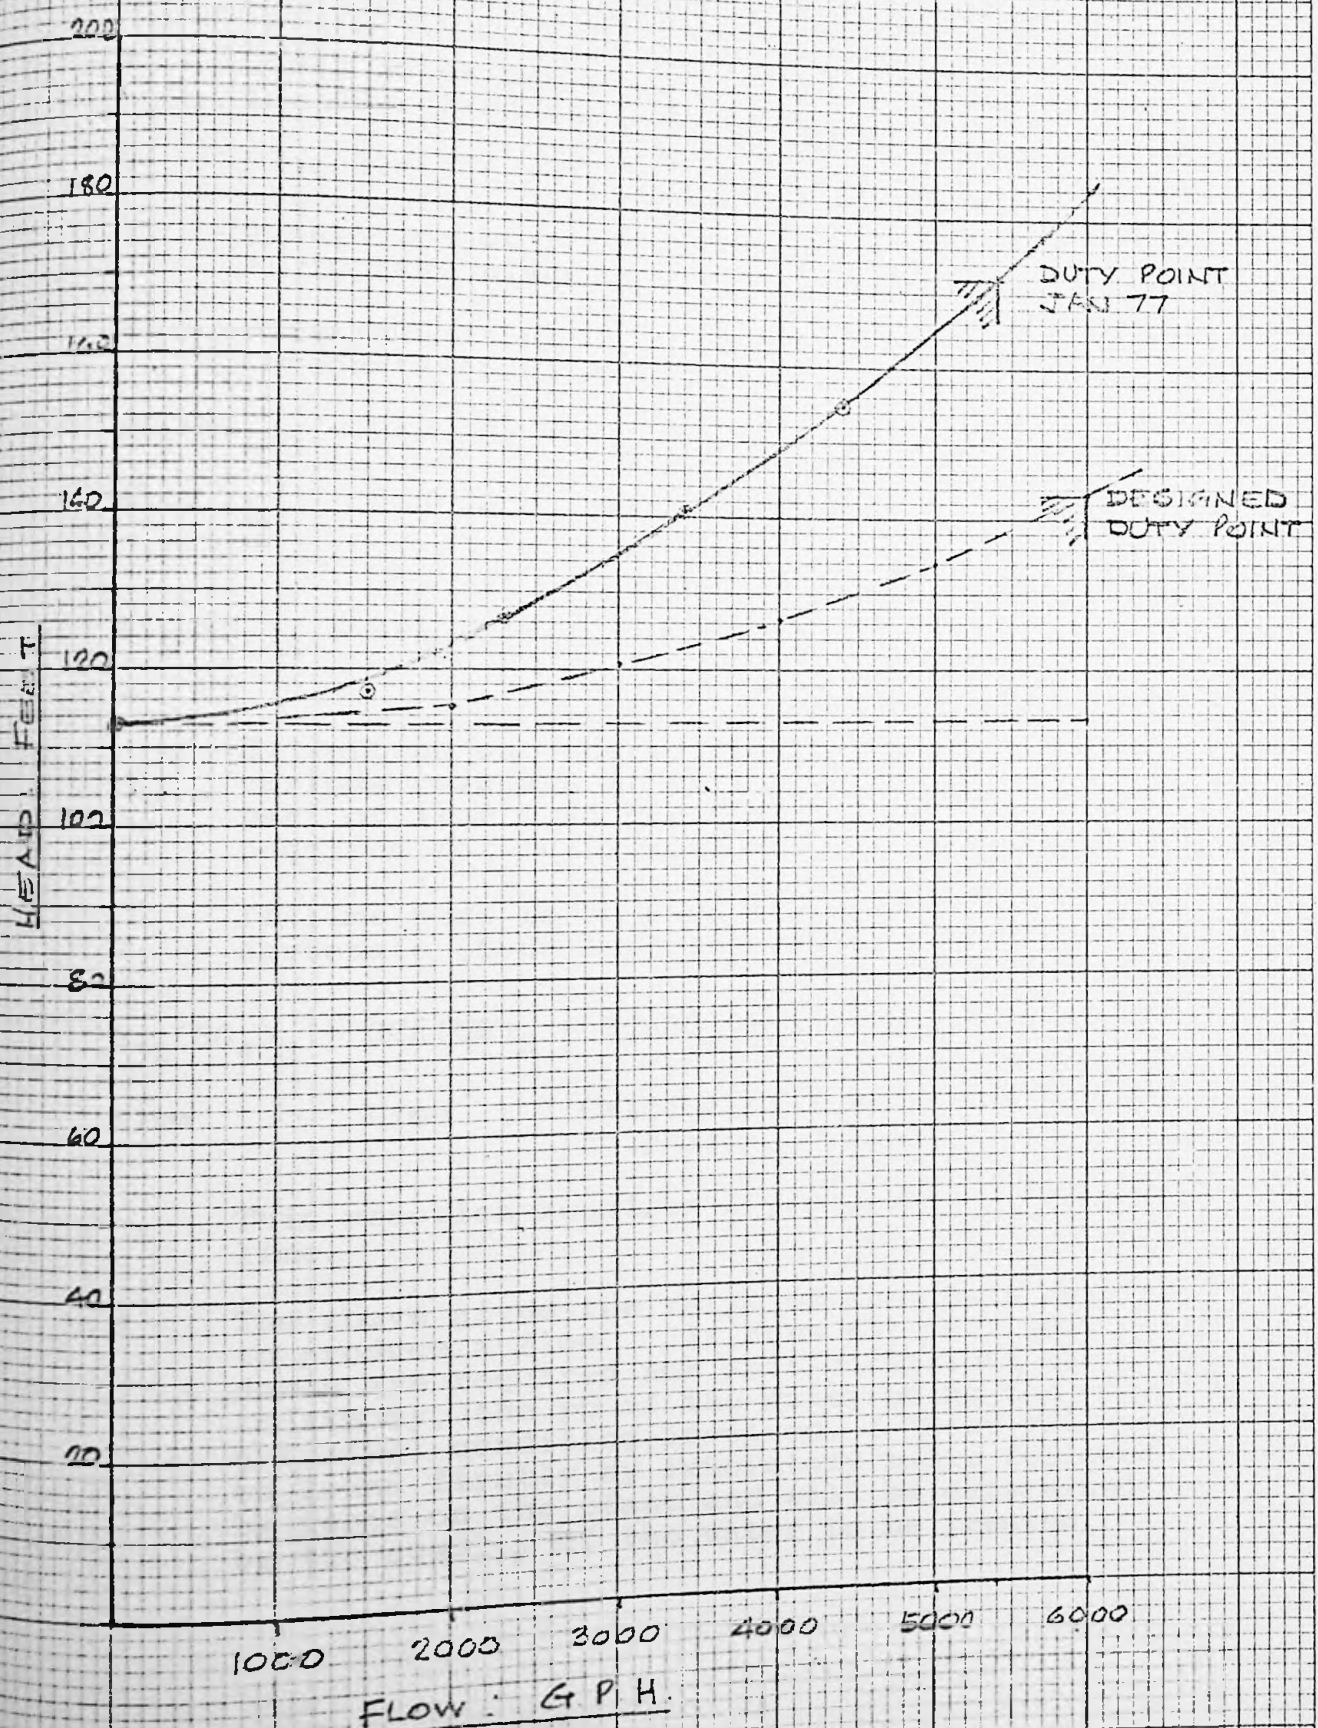
H/Q CURVE OF TREATED WATER PUMPING
MAIN AS AT JANUARY 1977

Since the output of both the old pump and the new one is the same it is reasonable to conclude that the decline in output is due to the interior condition of the main. A series of flow and pumping head readings were taken and these were plotted. The result is appended (Appendix 4). In his design Pope (P10.4) allowed for 14,000 ft of 6in NB cement lined pipe, 5.82in id, having a C value in Hazen William's pipe friction formula of 130. He gives a total friction head allowing 6.2 ft for specials of 30ft. The loss through 14000 ft of main given by Pope corresponds to a C value of 143 not 130. A value of 143 however is acceptable. The current value of C is only 84 indicating that there is probably a considerable deposit within the main or that the cement lining has been attacked by low pH treated water. In paragraph 5.3.1 mention is made of excessive alum and low pH of the final water. Both of these conditions are probably contributing to the increased pipe friction. The first requisite is that the treatment should be corrected and the second that the main should be cleaned out using a pig, sometimes referred to as a swab, to dislodge any slime adhering to inside of the pipe, followed by a flushing. This should restore the main to its original capacity, unless the low final pH found has had an opportunity to attack the cement lining in which case there may be little improvement.

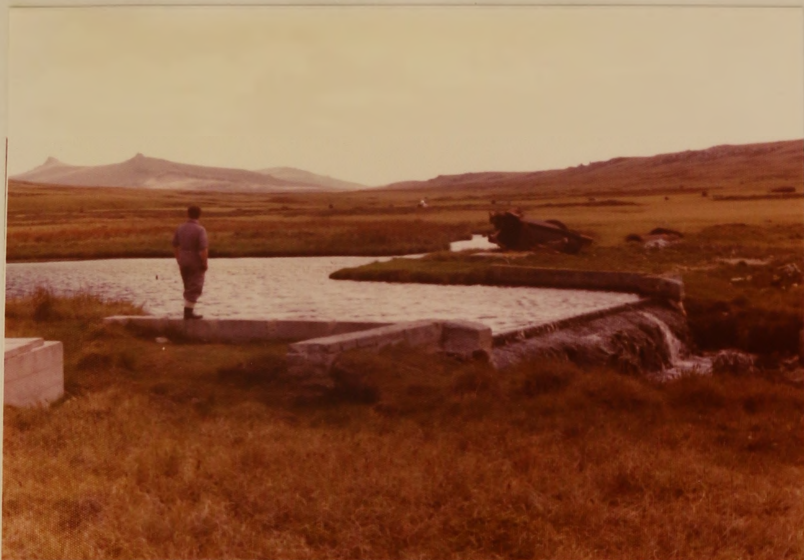
R/UT1/WAT/1#4-01

No 1 - MOODY BROOK INTAKE - 14/1/77
Showing surplus water after abstracting 5,400 gph

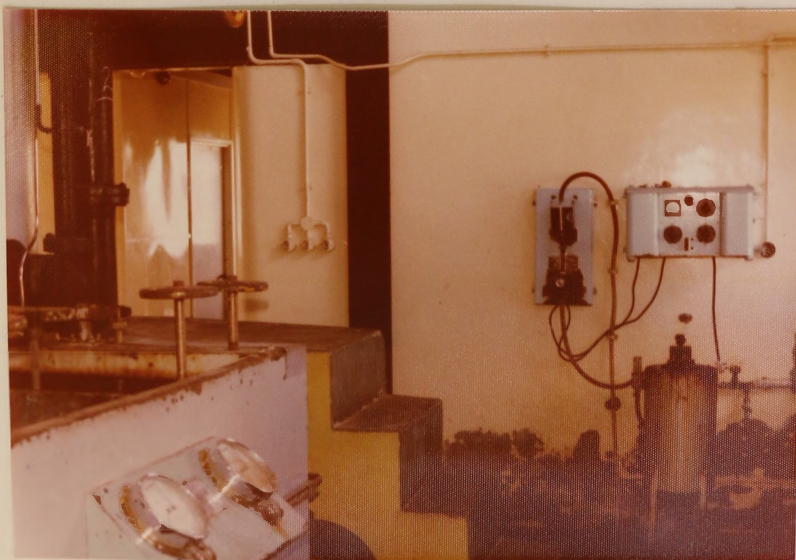
R/UT1/WAT/1#4-02

4.5.4 The condition of both plate steel filter outlet inspection chambers is poor. They urgently require cleaning out and repainting to prevent further corrosion which is already extensive.

4.6.2 Unfortunately the Clorocel Unit went unserviceable a few days before Mr Smith's arrival and replacement parts had not arrived in Stanley. Since it was no longer possible to sterilise the water pumped to supply, the Senior Medical Officer was advised and he authorized the broadcasting of a warning to consumers over the local radio to boil all drinking water as a precaution against water-borne pathogenic diseases. It had a further unfortunate effect that we were unable to check the working of the chlorinator or the effectiveness of the sterilisation both at the Works and in the distribution reticulation. The replacement unit was on board the chartered supply ship due in Stanley on 31 January 1977.

No 2 - INTERIOR OF TREATMENT WORKS - 14/1/77
Showing condition of Chlorinator, Filter Inspection
Chambers and building.

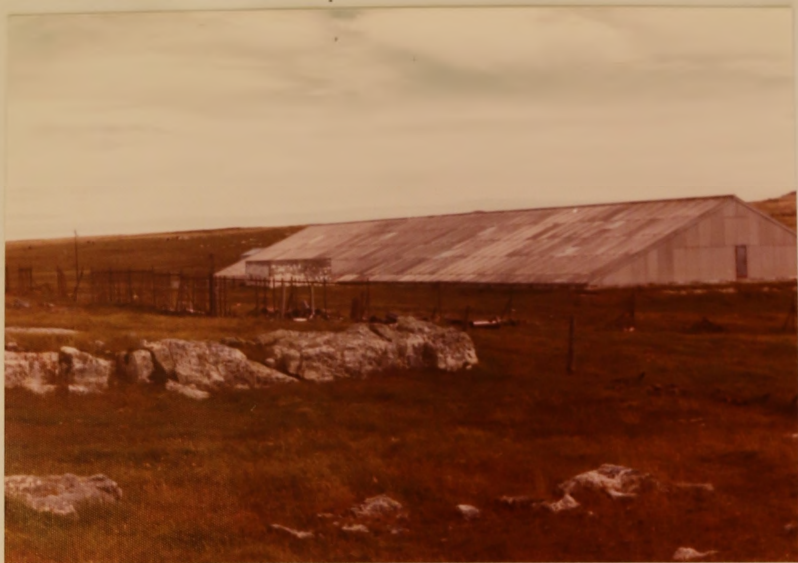
R/UTI/WAT/1#4-03

This reservoir supplies the lower areas of the town. It existed as an open reservoir supplied from the Mount William springs until the works recommended by Pope were constructed. At the same time a roof was put over the reservoir to protect the water from contamination. The roof of the reservoir is now in need of repairs to the asbestos cement sheeting which has been holed in a number of places. This damage is apparently not the result of human vandalism but from stones dropped by seagulls. The reservoir, we understand, has to be cleaned out at least once a year. This is probably due to existence of perspex transparent sheets in the roof which let in the daylight and promote algal growth. These sheets should either be replaced by asbestos cement sheets or simply painted over. Thereafter cleaning out should be carried with the assistance of artificial lighting. There is also evidence in the reservoir of excessive alum carry-over which also has to be avoided. This can be achieved by correct treatment. This is referred to later. The roof structure appears to be in good condition. Provision should be made for re-painting this within the next two years.

No 3 - DAIRY PADDOCK RESERVOIR ROOF - 17/1/77

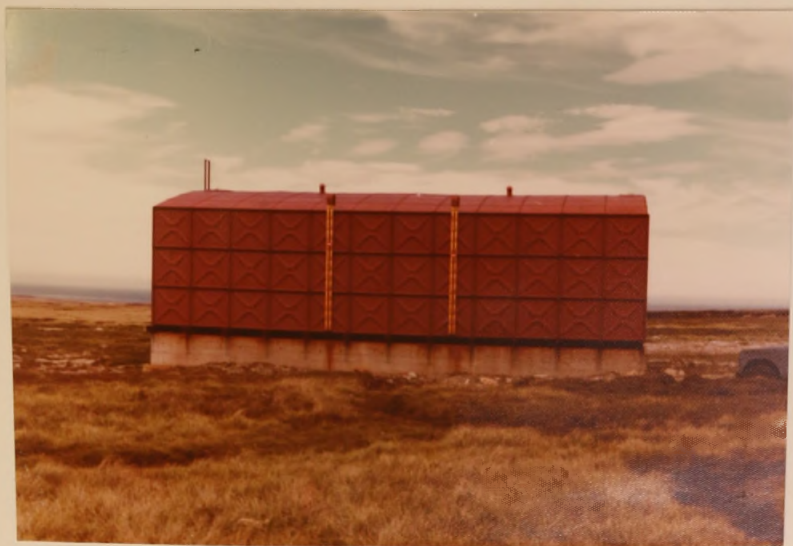
R/UTI/WAT/1#4-04

4.13.2 The Sapper Hill tank is built on sleeper walls with the floor about 3 feet off the ground. There is ample evidence both on the exterior surfaces and soffit of the floor plates that the tank is badly corroded within. It is confirmed locally that this is so and that the division has been equally attacked. Unless urgent remedial measures are taken this tank will soon become a write-off. At the moment it appears structurally sound and could be preserved by applying an epoxy resin lining. This tank forms an essential part in our proposals for providing an adequate supply of water for fire-fighting and should be properly protected as soon as possible.

No 4 - SAPPER HILL TANK - 17/1/77

supply of potable water. However if our proposals for the provision of an adequate fire-fighting water supply are adopted Sapper Hill Tank would have to be duplicated (see Chapter 8). If this is done at an early date it would facilitate the re-conditioning of the existing tank (4.13.2).

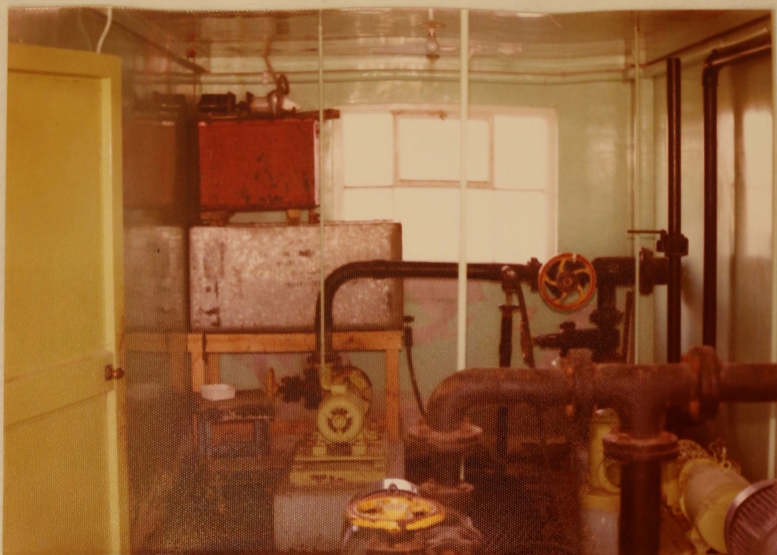
R/UT/WAT/1#4-05

No 5 - INTERIOR OF TREATMENT WORKS - 14/1/77
Showing Magnafloc mixing and gravity dosing tanks,
raw water pumps at rear, air scour blower on r h s
and treated water pumps in foreground

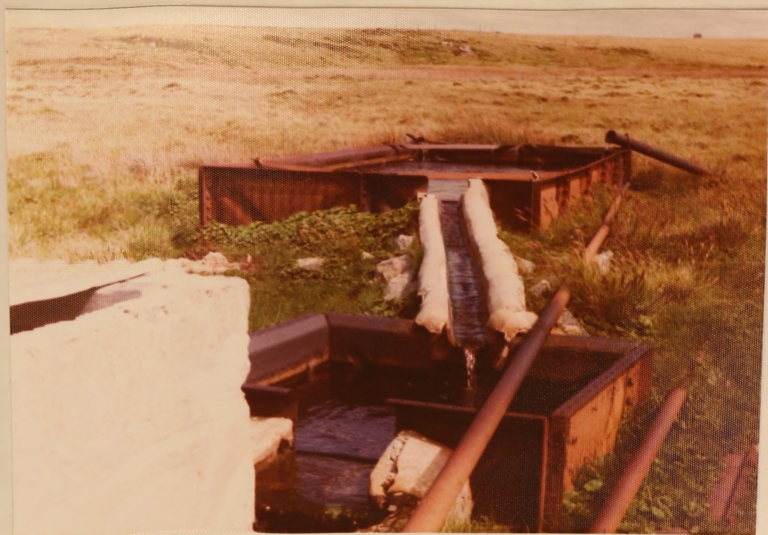
R/UT/WAT/1#4-06

These springs which, together with the springs in Mullet Creek, provided the supply to Stanley before the construction of the present Works, were inspected and gauged and were found to be yielding only 4750 gpd. Pope (P7.3) noted at the end of his visit that after a short period of dry weather the yield had fallen to 11,000 gpd and went on to assume that the minimum could drop below 10,000 gpd. It is obvious that the quantity of water available from these springs is negligible and there is no point in spending money on providing any pipes to divert the water into Moody Brook.

No 6 - MOUNT WILLIAM ABANDONED WORKS - 14/1/77
Showing 4,750 gpd issuing from springs

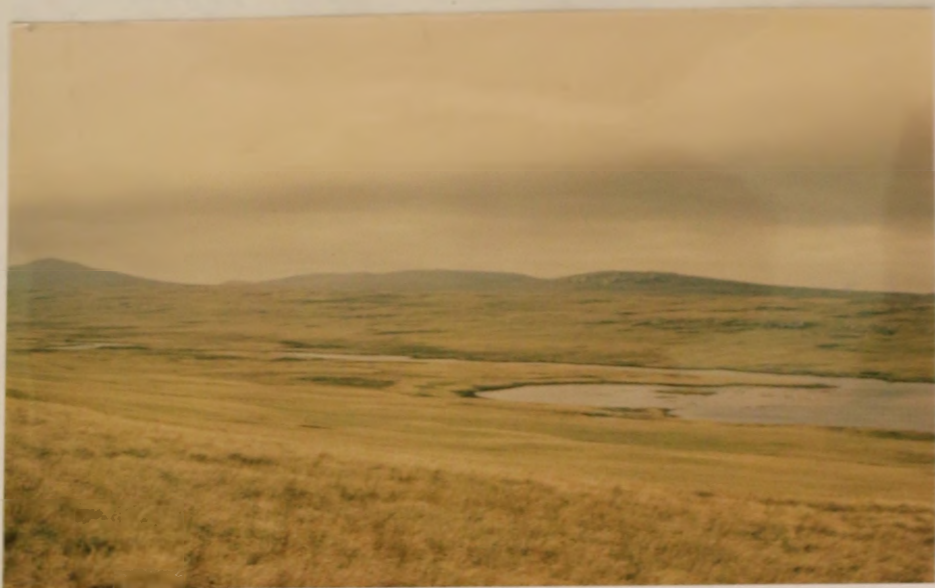
R/UTI/WAT/1#4-07

No 7 - ESTUARY OF MURREL RIVER - 26/1/77

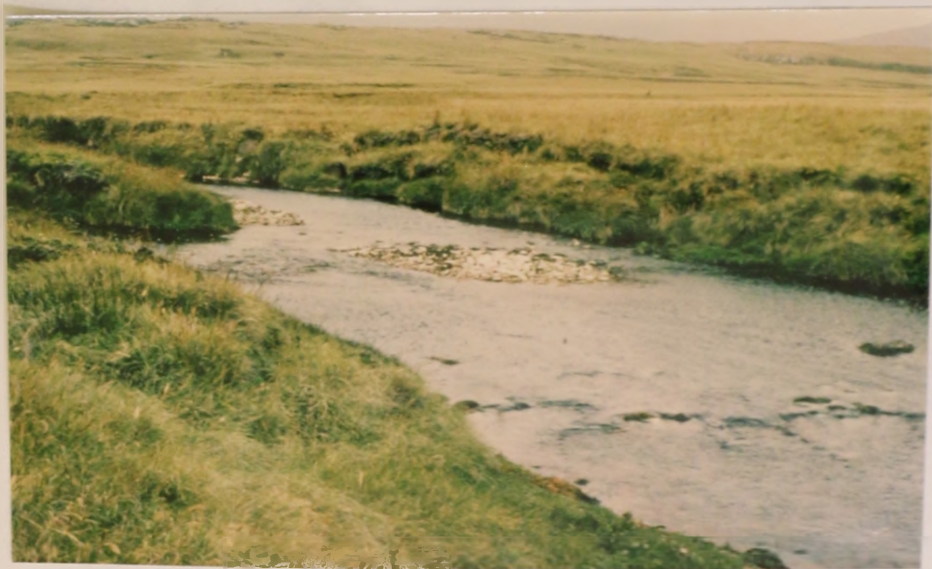
R/UTI/WAT/1#4-08

No 8 - MURREL RIVER FLOW - 26/1/77
Site of former gauging station
