COLONIAL LIGHTS

CAPE PEMBROKE LIGHTHOUSE

MENGEARY POINT LIGHTHOUSE

on condition of lighthouse stations, following survey
carried out during period 29th April, 1959, to 6th May,
1959, with recommendations for improvements,

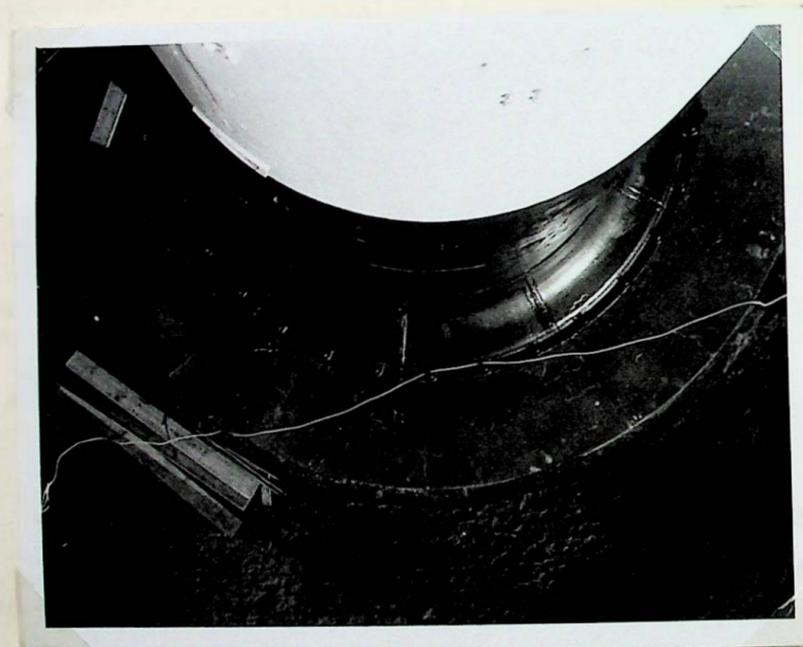
④

The weight tube, which runs from the service room floor to the tower base is in good condition, also the weights and access doors.

Two panes of glass in the tower windows are cracked and these should be replaced with 32 oz. glass.
