FALKLAND ISLANDS

CAPE PEMBROKE LIGHTHOUSE

NAVIGATION AIDS IN PORT WILLIAM

CIVIL SECTION,
ENGINEER-IN-CHIEF'S DEPARTMENT,
TRINITY HOUSE.

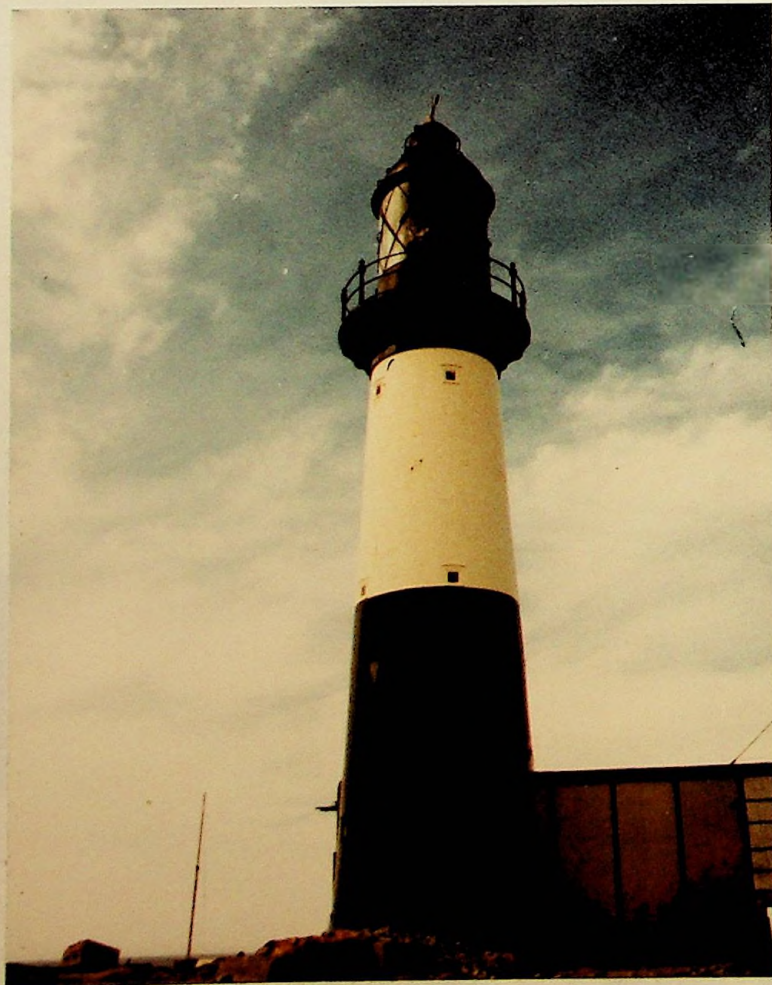
- 02

The tower appears structurally sound apart from one major and one minor crack visible in the base section.

Some paint blisters and minor rust patches are visible on the exterior of the tower. It is evident that the tower was fairly well maintained up until the invasion, but the paint finish is uneven due to repeated chipping and repainting, and could well benefit from total grit blasting and repainting.

TOWER

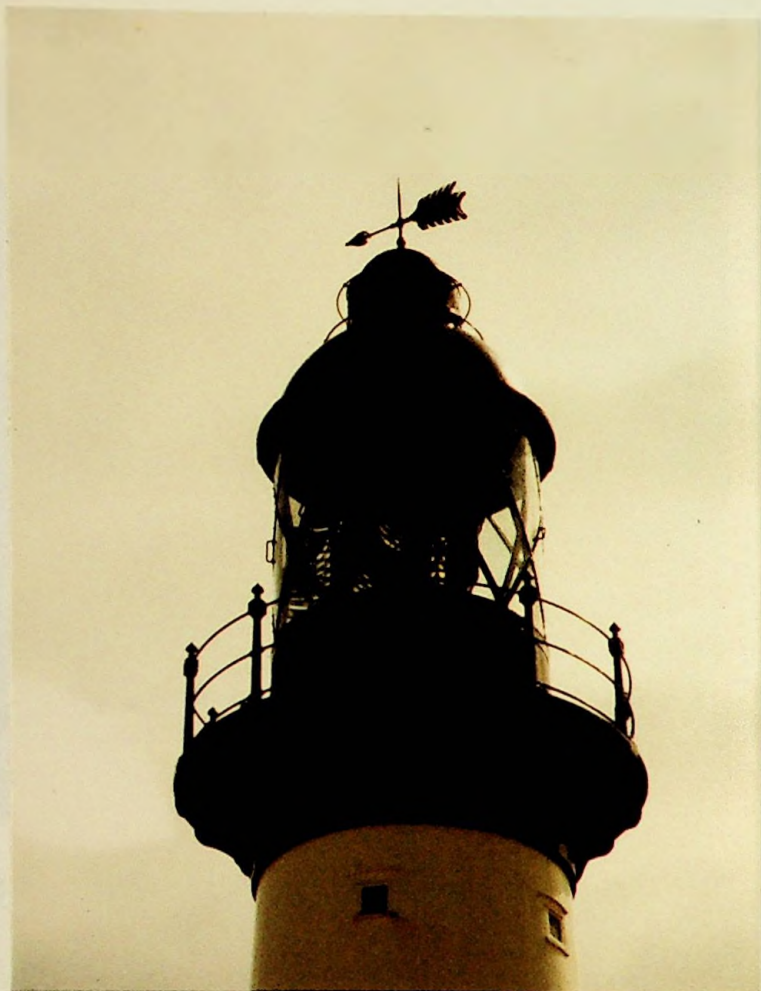
-03

A bullet hole can be observed in one of the glazing diamonds. Some damage has occurred to the prisms on the optic also caused by the same projectile. Additionally one of the upper half diamonds is cracked. Not 2.

LANTERN AND GALLERY

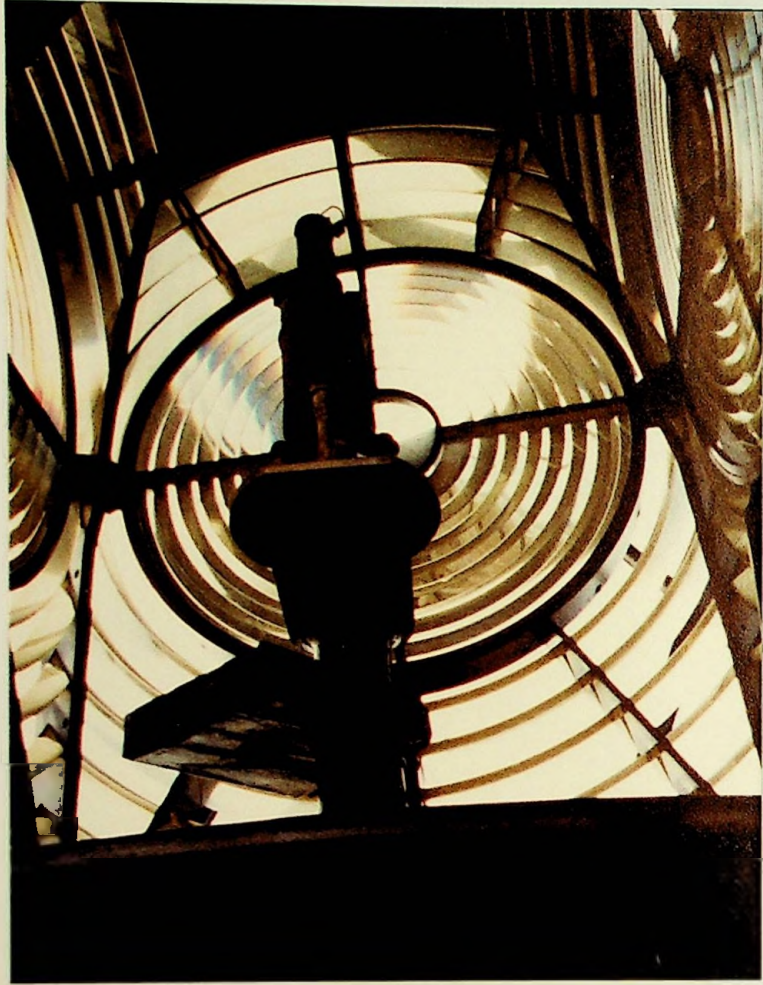
-09

The optic drive mechanism is in poor condition, the horizontal rollers have been removed, several were found at ground level in a rusty condition, and the mercury has been drained from the bath.

INTERIOR OF OPTIC
