REPORT ON FIRE FIGHTING SERVICES
IN THE
FALKLAND ISLANDS

FIRE PREVENTION INSPECTION REPORTS.

FIRE PREVENTION REPORT.

KING EDWARD MEMORIAL HOSPITAL.

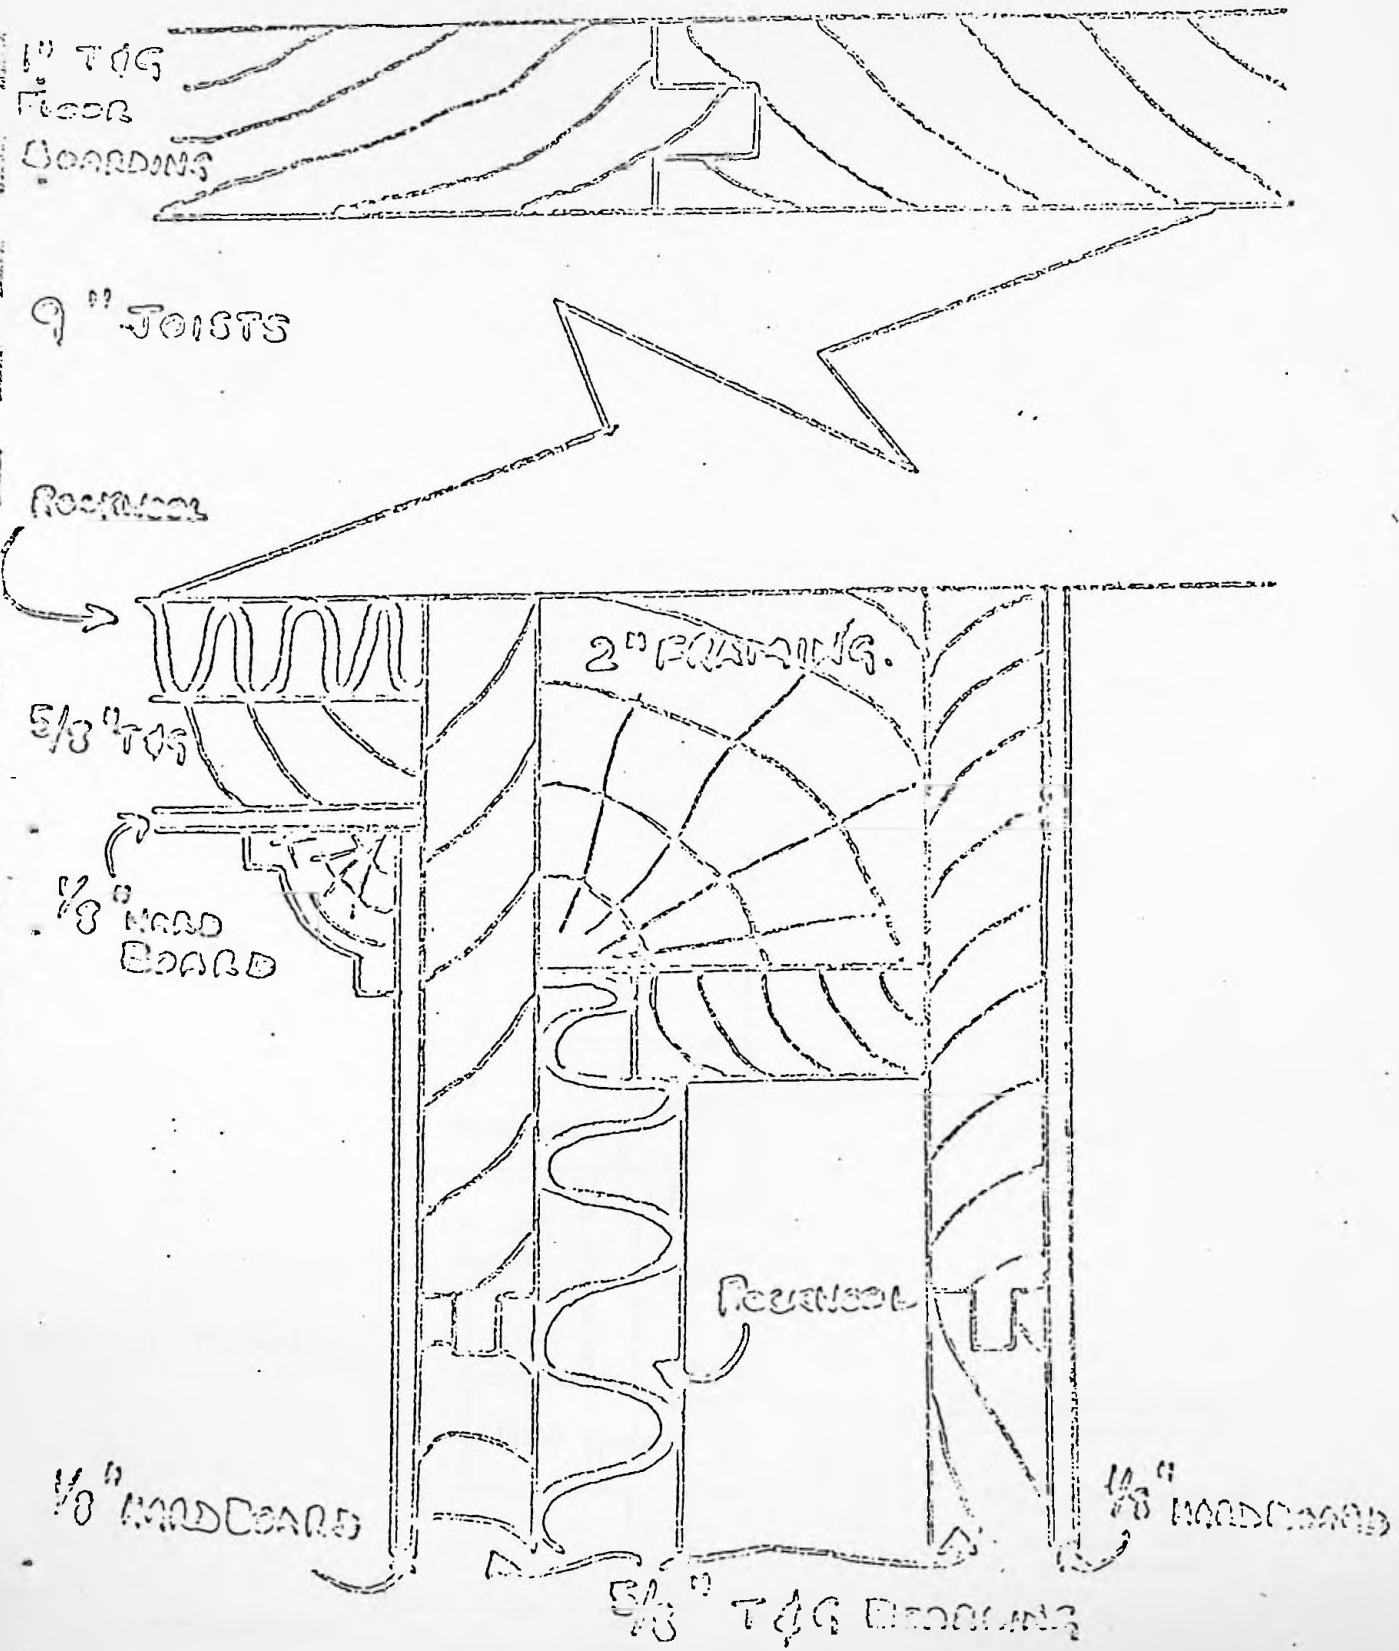
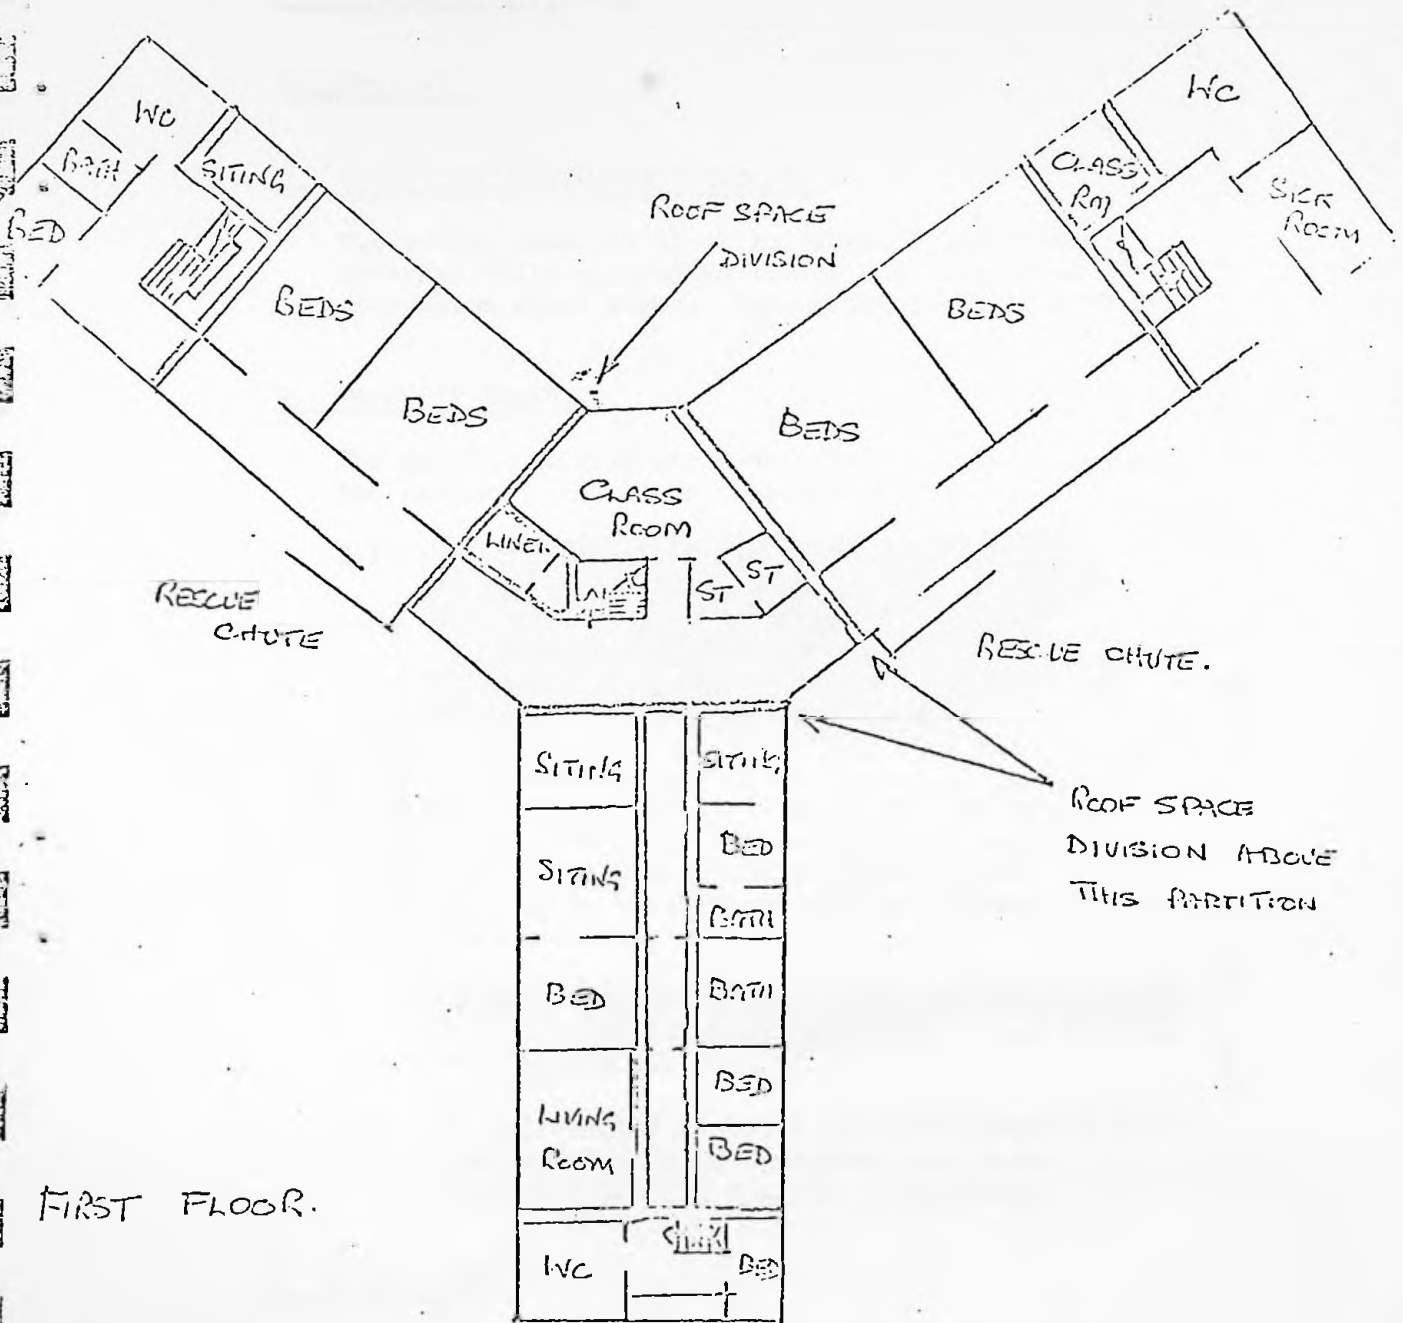
FLOOR & WALL CONSTRUCTION.

FIRST FLOOR.

DARWIN SCHOOL

RECOMMENDED FIRE RESISTING
CONSTRUCTION OF DOORS

- 2.1. The internal stairway to be protected by enclosing this at ground floor level with fire resisting construction. A screen with a half hour fire resisting door to be provided across the rear of the entrance lobby to form a stairway enclosure. The two open sections of the stairway banister to be infilled with fire resisting material. The internal wall to the Income Tax Office to be lined with fire resisting materials. The door to the Treasury Office to be replaced by a half hour fire resisting self closing door.
- 2.2. All exits from the ground floor offices to open to be made immediately available during the time the premises are occupied.
- 2.3. All combustible material should be removed from corridors and no combustibles are to be allowed within the stairway enclosure.
